FROM THE NORTH DAKOTA STATE WATER COMMISSION

2018 State Water Commission Construction Season

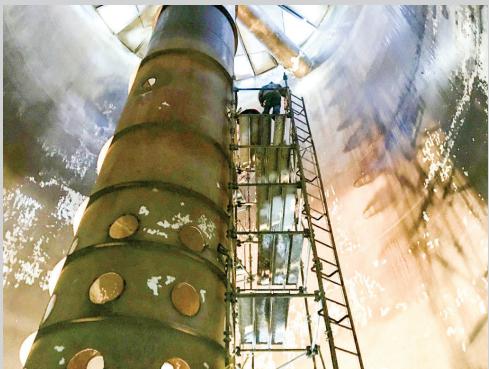
SWC construction crew members cutting additional holes in the center core of a standpipe.

Lake through a system of canals and pipes to an outfall structure along the Sheyenne River, fourteen miles away. The project consists of two pump stations. Each pump station has a standpipe that maintains a constant pressure on the pumped portions of the system. In past operating seasons, the standpipes would develop foam that would build up to the point it blew out of the vents at the tops of the tanks.

In 2017, work was done to try to reduce or eliminate the foam buildup. This work consisted of cutting holes in the center core of each standpipe to change the turbulence at each operating water level. This initial effort was mostly successful in reducing the foam build up. However, it was found that additional holes were needed in the Round Lake standpipe at the maximum water level elevation. In February 2018, the SWC construction crew, along with the outlet operations staff, erected scaffolding and cut additional holes at the max water level. The standpipe operated without any foam issues throughout the 2018 pumping season.

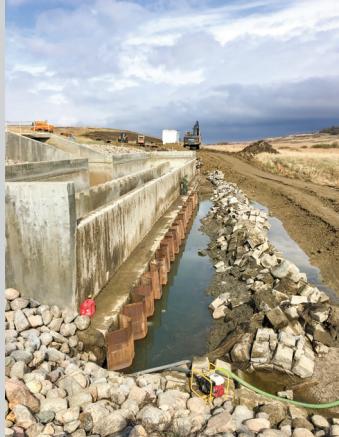
The East End Outlet was temporarily shut down for twenty days to conduct repairs.

Over the previous several pumping seasons, the impact of the discharge spilling onto the concrete block displaced the block, and the soil at the base of the outfall structure began to erode away. In 2018, repairs were required at two separate areas of the outfall structure to prevent undermining of the structure.

The first repair took place prior to the start of the 2018 pumping season and consisted of driving piling along the toe of the reinforced concrete spillway structure and filling the space behind the piling and under the structure with a flowable concrete fill to replace the eroded soil and prevent future erosion.

The second repair took place in August and was required after a separate area of erosion formed at the sheet pile wall which was placed during original construction in 2012. For this repair, the outlet was shut down for twenty days, the area was excavated, and a separation in a seam of the sheet pile wall was observed. This separation of the seam was likely caused by a large rock encountered during initial construction and resulted in a seepage path which eventually led to the damaging erosion. For this repair, both sides of the wall were excavated, a secondary wall was driven, and the hole was filled with concrete to prevent future erosion. The wall was then backfilled with rock to provide additional energy dissipation. With these repairs completed, the East End Outlet was able to provide reliable operation for the remainder of 2018 and is prepared to serve the region into the future.

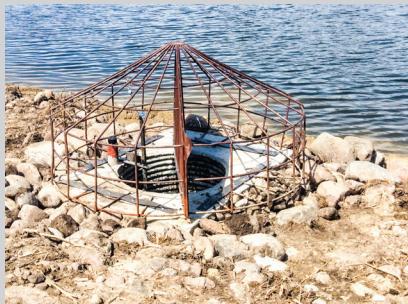
These repairs will ensure beneficial use for recreation.

The CMP riser developed leaks leading to loss of water from the reservoir. The joint at the riser to conduit connection had ruptured, allowing water and soil to leak through the opening - resulting in a sinkhole around the riser. The valve for the low-level outlet was also heavily rusted. In 2017, the LaMoure County Water Resource District requested cost-share, along with technical and construction support from the Water Commission to repair the principal spillway.

The repairs began in June 2018, with the construction of an earthen coffer dam. This was followed by excavation of the riser. Forms were then placed around the existing CMP riser to create a reinforced concrete drop structure, using the CMP as the inside form. New fittings for the low-level outlet were cast into the new concrete and a new valve and operator stem were installed in the riser. The structure was then backfilled and the cofferdam was removed. The borrow site was reclaimed and seeded. With these repairs, Schlenker Dam will continue to provide a place for anglers to enjoy the North Dakota outdoors for years to come.

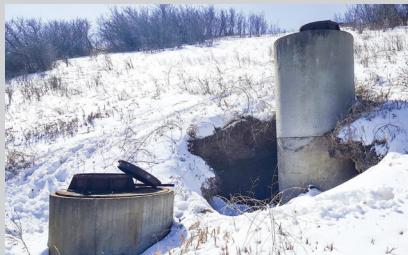
A sink hole discovered on April 10, 2018.

The dam has two low-level drawdown systems, used primarily for water quality improvement in the reservoirs, one in each embankment. The low-level drawdown systems consisted of 12-inch ductile iron pipe (DIP) conduits with gate valves at the downstream end. Outlet works with valves at the downstream end, referred to as "downstream control" were once popular in dam construction because they are easier to construct and cost less than upstream control systems. However, downstream control presents a risk of dam failure if the pipe full of water near the downstream toe of the dam starts to leak. A possibility made more likely by the fact the conduit is made of iron. That is what happened at the west embankment of Daub Dam in the spring of 2018. Fortunately, it was found quickly by Game and Fish staff before significant damage to the embankment occurred. The west reservoir was quickly drained to prevent further damage to the embankment and loss of this important transportation corridor.

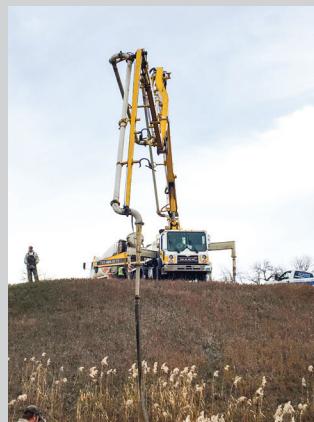
Concrete truck pumping concrete grout for the project.

The State Water Commission construction crew filled the existing low-level conduits with a cement grout to seal them and eliminate the risk caused by the high-pressure water near the toe of the dam. In the spring of 2019, the plan is to install a new outlet conduit with control on the upstream side of the dam into the west embankment's principal spillway.
