2019 WATER COMMISSION CONSTRUCTION SEASON RECAP

During the 2019 Construction season, the State Water Commission’s design and construction section conducted repairs and modifications to water resource structures throughout the state, as well as assisting in Devils Lake outlet operations. Below are a handful of projects completed in the last 12 months.

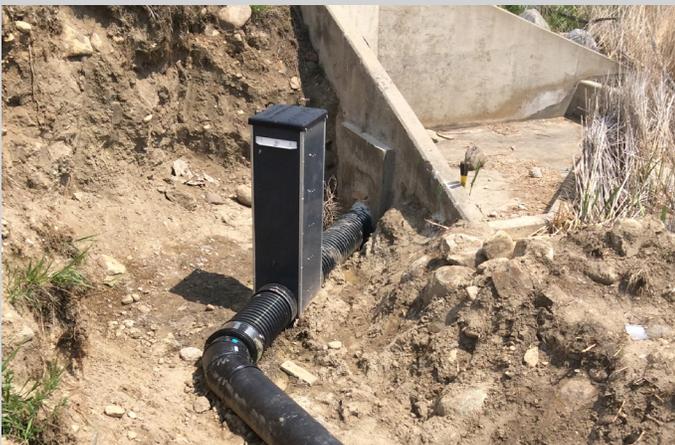
DAUB DAM, MERCER COUNTY

View of the new low-level outlet pipe, entering the principal spillway structure.

Daub dam had two low-level drawdown systems, one in each embankment, which were used primarily for water quality improvement in the reservoirs. The low-level drawdown systems consisted of 12-inch ductile iron pipe (DIP) conduits with gate valves at the downstream end. Outlet works with valves at the downstream end, referred to as “downstream

However, downstream control presents a risk of dam failure if the pipe full of water near the downstream toe of the dam starts to leak. A possibility made more likely by the fact the conduit is made of iron. That is what happened at the west embankment of Daub Dam in the spring of 2018. Fortunately, the leak was detected early by Game and Fish staff before significant damage to the embankment occurred. The west reservoir was quickly drained to prevent further damage to the embankment, avoiding the potential loss of this important transportation corridor.

The project was completed in the spring of 2019 when the new low-level outlet was constructed. This consisted of installing approximately 300 feet of pipe into the reservoir and connecting it to the west embankment’s principal spillway, with a control structure on the upstream side of the dam, eliminating the hazard of pressurized water inside the embankment.

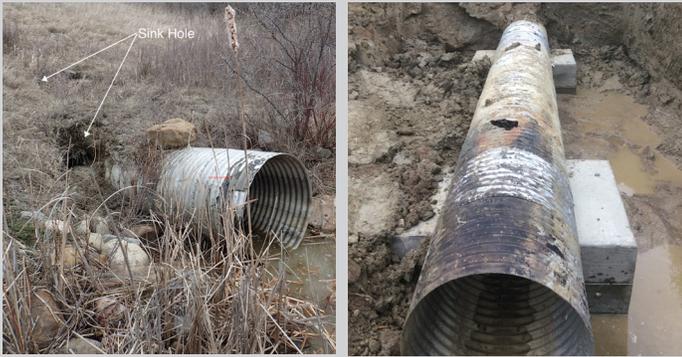
DAVIS DAM, SLOPE COUNTY

Before repairs were conducted, sagging and warping of the pipe and a sinkhole was forming. The pipe is shown with new supports after repairs were completed.

In spring 2019, a sinkhole was observed above the principal spillway conduit a short distance from the downstream toe of the dam. The conduit is a 36-inch corrugated aluminum pipe. Further investigation revealed that the last section of pipe, added during the dam raise in 1985, had separated from the original pipe. The separation allowed embankment material to erode through the opening, creating the sinkhole.

The Water Commission's construction crew excavated and removed the downstream piece of pipe, constructed a concrete footing under the joint where the two pipes meet to better support the joint, and reinstalled the pipe with a new, wider connecting band to ensure the joint remains tight for years to come. The conduit was then backfilled, and the site was restored by seeding the disturbed areas. The crew also made a repair to the concrete floor of the principal spillway drop structure, where the concrete had deteriorated over the years.

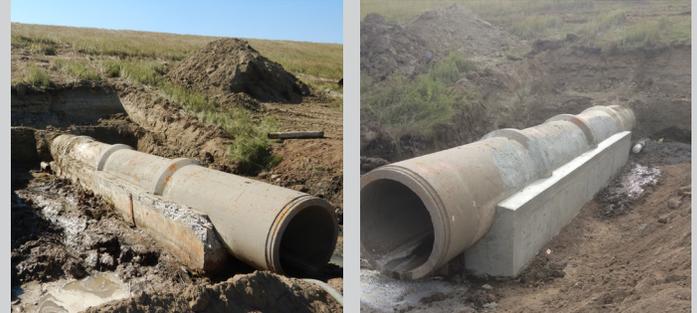
INDIAN CREEK DAM, HETTINGER COUNTY

Over the previous several years, the concrete cradle supporting the 36-inch reinforced concrete pipe (RCP) of the principal spillway has been deteriorating. This led to the supports for the toe-drain pipes dropping into the plunge pool, with the end section of RCP soon to follow.

Prior to repairs, the footings for the pipe were deteriorating. After construction was finalized, the pipe was intact and reinforced.

The Water Commission's construction crew excavated the downstream end of the RCP conduit and cradle, demolished the cradle, and removed the RCP conduit sections. This also required removing the downstream sections of the toe-drain pipes. The toe-drains were asbestos-cement-pipe (ACP), which required special asbestos abatement procedures performed by an asbestos abatement contractor.

With the demolition completed, forms were constructed and concrete was placed for a new concrete cradle to support the RCP conduit and toe-drains. The toe-drain sections were replaced with PVC pipe since ACP is no longer installed for water conveyance. The conduit and cradle were then backfilled and graded. The final site restoration has been put off until spring 2020 due to very wet conditions at the site.

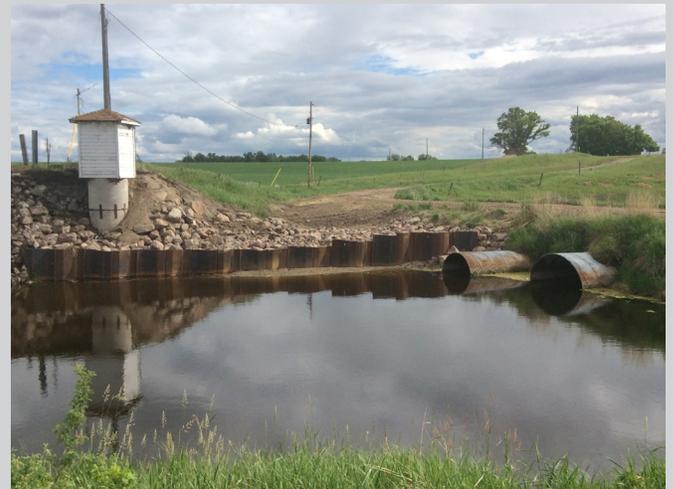
Maintenance at the USGS gage at Deep Creek in Bottineau County.
