Investigation Report – McGregor Dam

Williams County, North Dakota

SWC Project #528
July 2018

Investigation Report -McGregor Dam

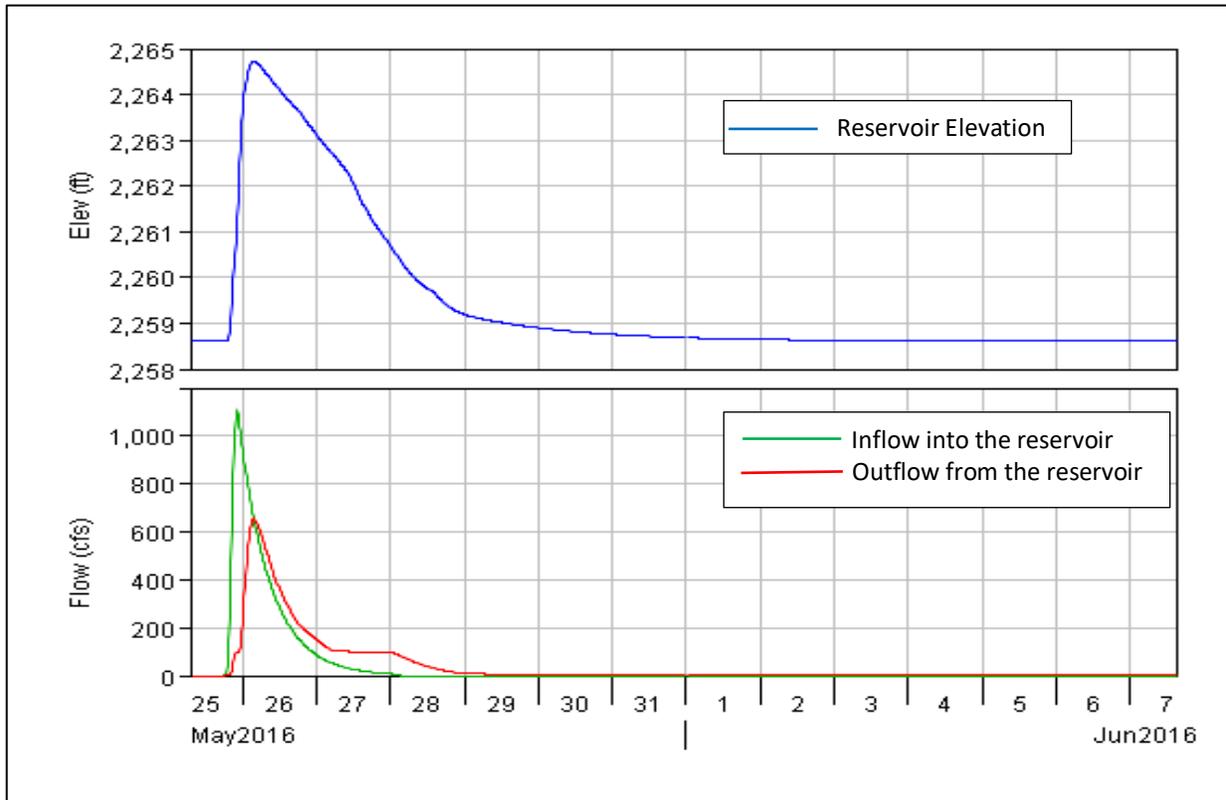
Figure 9. Pool elevation, inflow, and outflow for the P₁₀₀ case.

During the inflow of the P_{100} event, the pool crested at approximately elevation 2264.7 ft, 2.2 ft above the elevation of the emergency spillway crest (Figure 9). Therefore, the capacity of the principal spillway does not satisfy the dam safety standard.

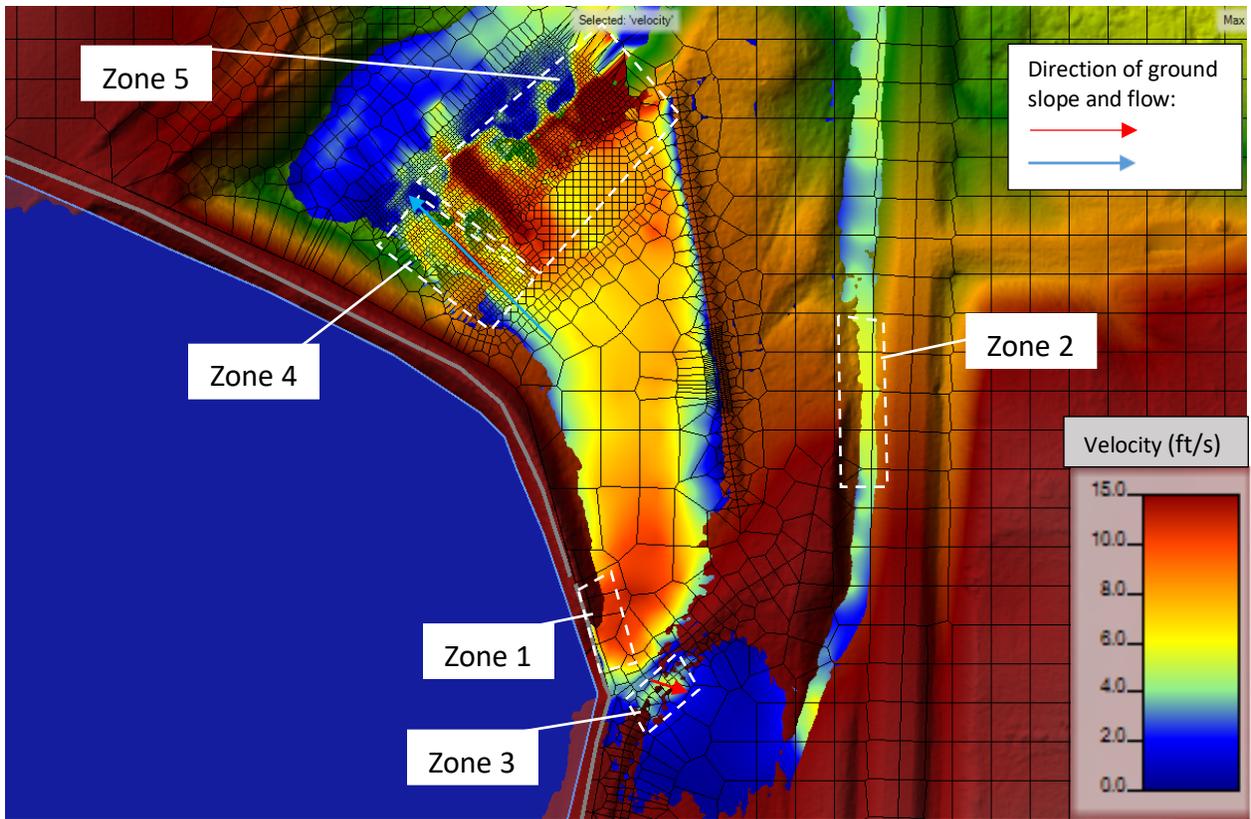
Figure 10. Discharge velocities downstream of the emergency spillway.

The velocity analysis revealed additional erosion issues. In Zone 2 (Figure 10), the flow velocity increases up to 5.6 ft/s as water flows along the Highway 50 ditch. This situation increases the risk of erosion damage to the highway. In Zone 3 (Figure 10), eastward flow accelerated up to 5 ft/s through the down slope (Figure 12(a)). Water flowing through this zone would most likely cause erosion and increase the risk of higher magnitude flows being diverted along Highway 50. In Zones 4 (Figure 12(b)) and 5, the northwestward flow accelerated through down slopes up to 12 ft/s and 24 ft/s, respectively. Since Zone 4 is adjacent to the embankment toe, with Zone 5 in close proximity, the high velocity flow in these zones would most likely increase the risk of erosion and collapse of the middle of the embankment.

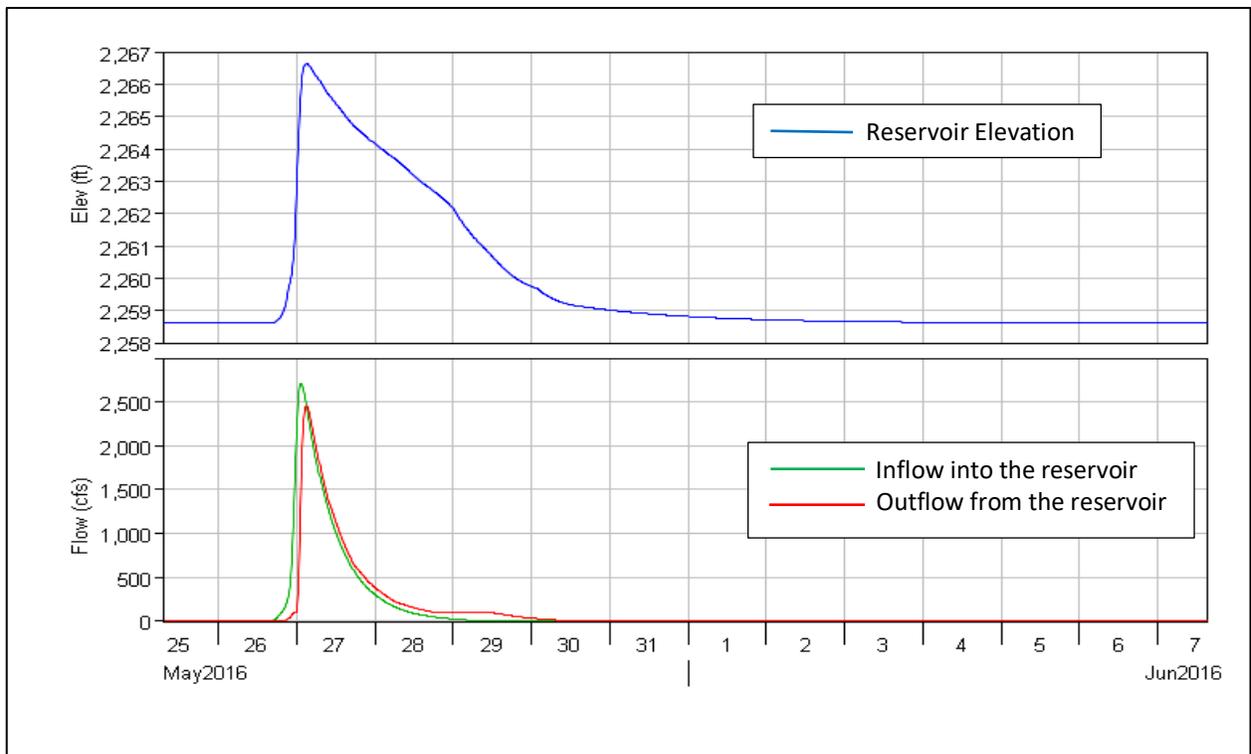
Figure 11. Pool elevation, inflow, and outflow for the 0.4 PMP case.

In the case of the 0.4 PMP event, the maximum pool elevation was between the emergency spillway crest and top of embankment. At the maximum pool elevation of 2266.6 ft, discharge was 2,450 cfs (Figure 11) and velocity was up to 12 ft/s at the nominal emergency spillway and immediate downstream face of the embankment (Zone 1 in Figure 10). The simulated velocity surpasses the allowable permissible velocity; and therefore, does not meet the dam safety standard.

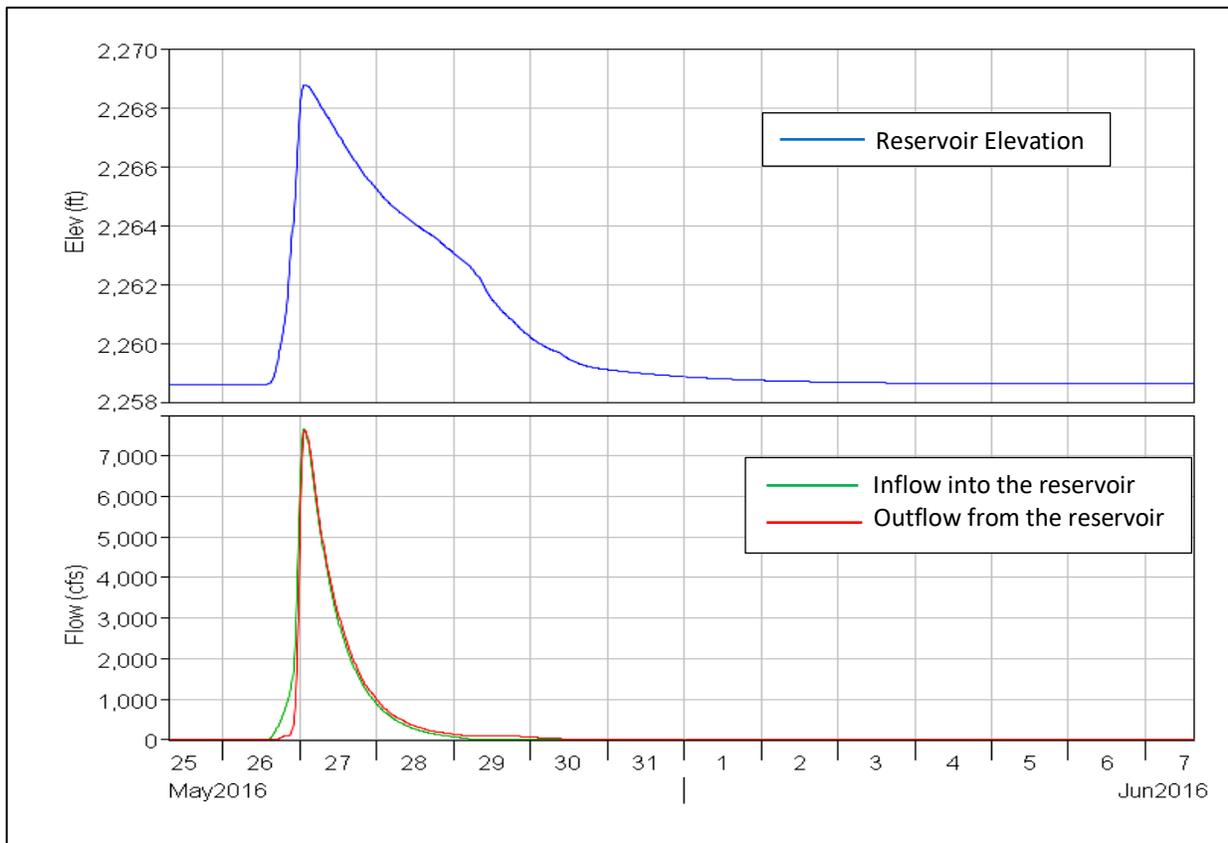
Figure 13. Pool elevation, inflow, and outflow for the PMP case.

The maximum pool elevation during the PMP event was 2268.8 ft, 0.5 ft below the top of embankment. Since the emergency spillway, augmented by the extra flow area, has sufficient capacity to pass the full PMF (Probable Maximum Flood) event, the embankment is not overtopped. However, the maximum discharge was over 7,600 cfs, and inflow and outflow hydrographs are identical. The dam has no flood control function for a PMP event (Figure 13).

It should be noted that the maximum reservoir elevation is very close to the top of the embankment. If a PMP event occurred with wetter antecedent conditions or a higher starting reservoir elevation than modeled, the dam would most likely be overtopped. Considering that undetected errors may exist in data collection/processing and calibrations of models, it is strongly suggested that the dam be considered as overtopped.
