MISSOURI RIVER BANK EROSION GARRISON DAM TO LAKE OAHE

Project No. 576

**NORTH DAKOTA
STATE WATER COMMISSION**

December 1997

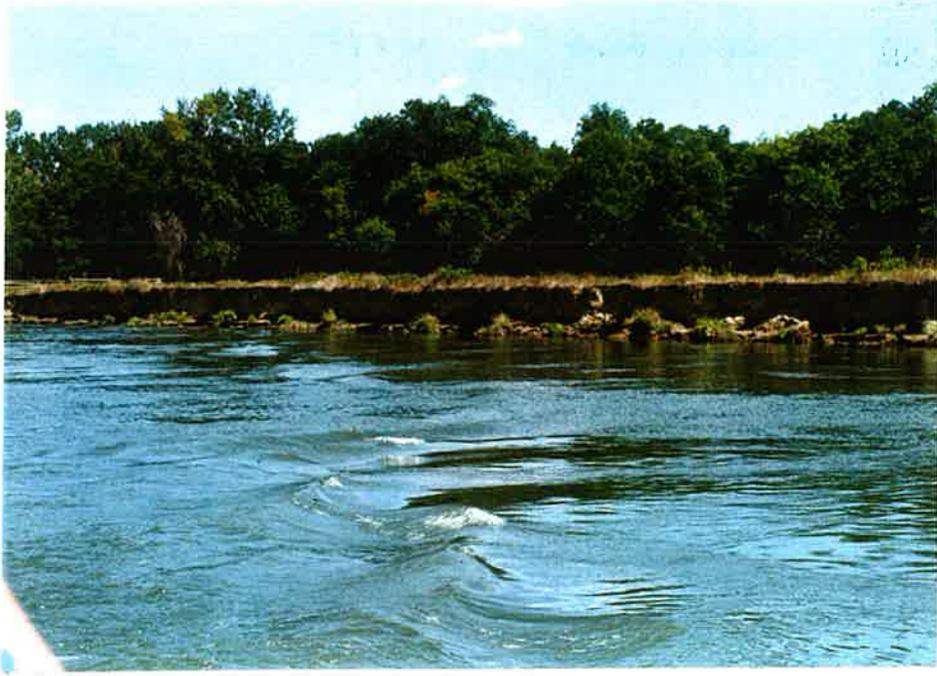
PHOTO 1

Bank erosion along the Missouri River has been a continuing problem since closure of the main stem reservoirs. Since completion of the Missouri River main stem reservoirs, the building process of high floodwater of the past are now non-existent, halting the rebuilding of bottom lands. Only low sandbars reaching to upper levels of the currently fluctuating river are formed. Therefore, the present bank erosion results in the permanent destruction of bottom lands, widening of the riverbed, and a continuing net loss of land [Photos 1 and 2].

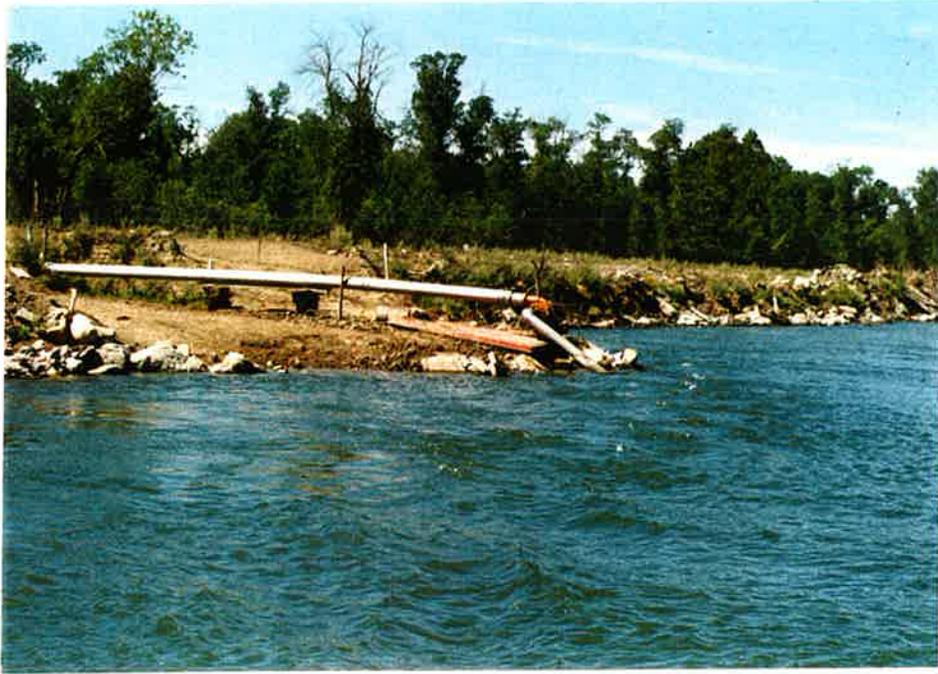
PHOTO 3

The siting of irrigation pumps [Photo3] along the Missouri River has been restricted because of bank erosion. The bank erosion discourages and in some cases prevents the irrigation of adjacent land. Only a few farmers along the river are fortunate to have pump sites located on naturally hard banks or where a bank stabilization project has been constructed. Additional bottom lands would be irrigated if the banks were protected from erosion.

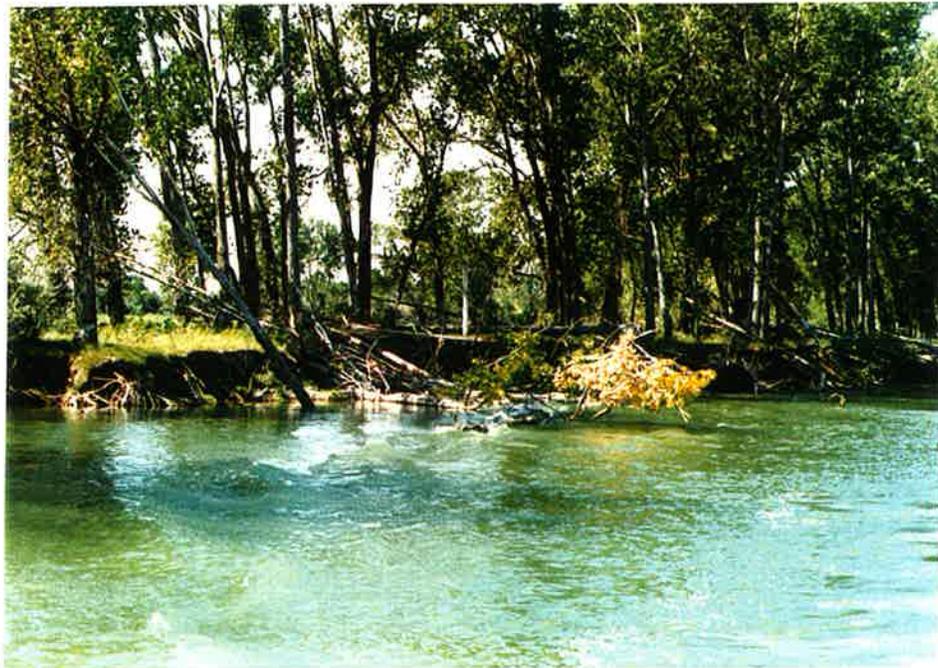
PHOTO 4

The river is causing erosion in some areas of natural hardwood forests [Photos 4 and 5]. These areas are the few remaining along the Missouri River. Woodlands are rare in the state of North Dakota as well as other prairie states occurring mainly along rivers. Many of the forests are already lost due to past logging and farming and due to the inundation of the pools of the main stem reservoirs on the Missouri River.

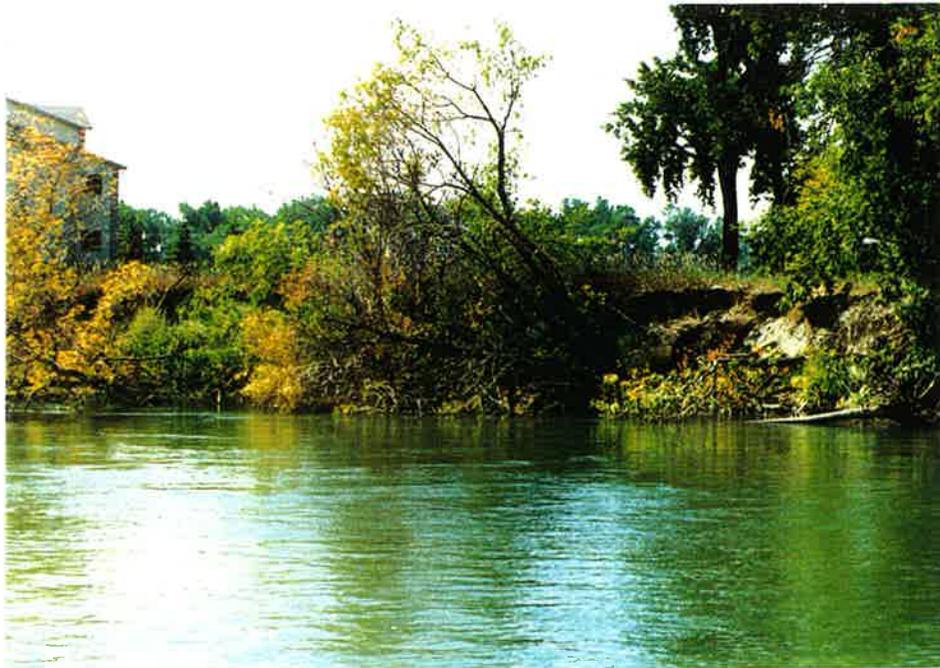
PHOTO 6

Bank erosion along the Missouri River continues to cause problems [Photo 6]. The problems will continue to occur and accumulate if no action is taken, causing ever increasing economic impacts. The Corps of Engineers has stated that bank erosion, unless halted, will gradually transform the present river into a wide area of sandbars, channels, and islands occupying most of the valley floor between bluffs. Photo 7, an aerial photograph of river mile 1334, depicts this situation. The future condition of the river as described by the Corps will make boating, fishing, and withdrawal of water for off-river uses almost impossible. Stabilization efforts should not be viewed solely as an effort to protect adjacent lands but also as an effort to protect the river.
