The Planning, Construction, and Operation of an Aquifer Recharge and Recovery Infiltration Basin in Grand Forks County, North Dakota

By
William M. Schuh, Jon Patch, and Ben Maendel

Water Resources Investigation No. 47
North Dakota State Water Commission

2009

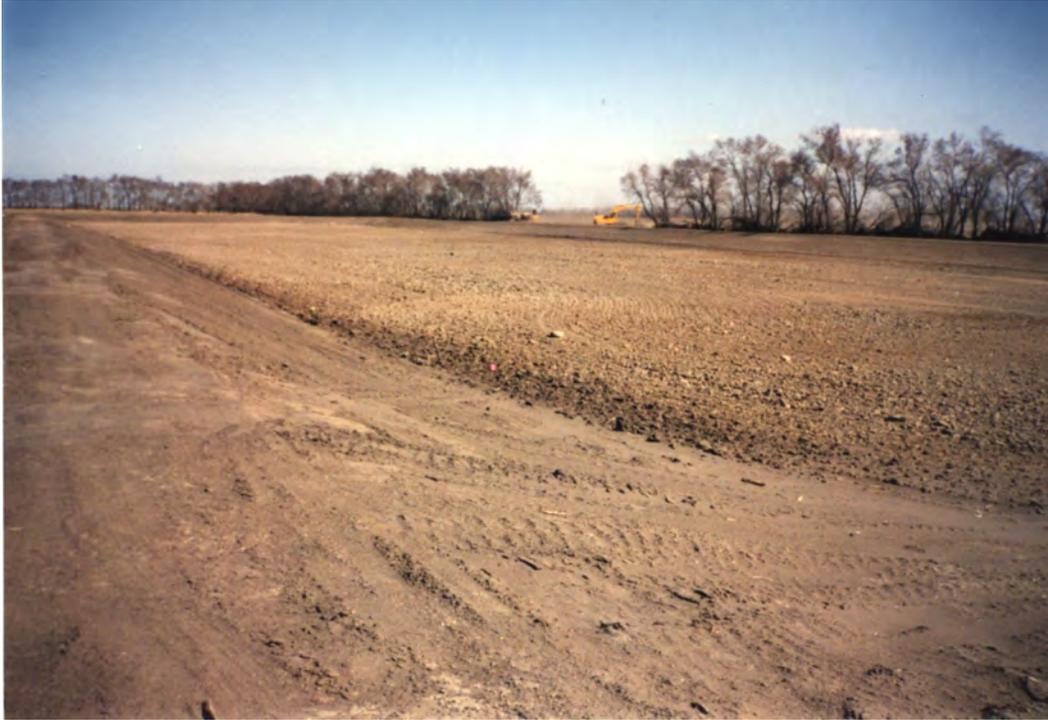
Newly-Constructed North (Rectangular) Infiltration Basin (1994)

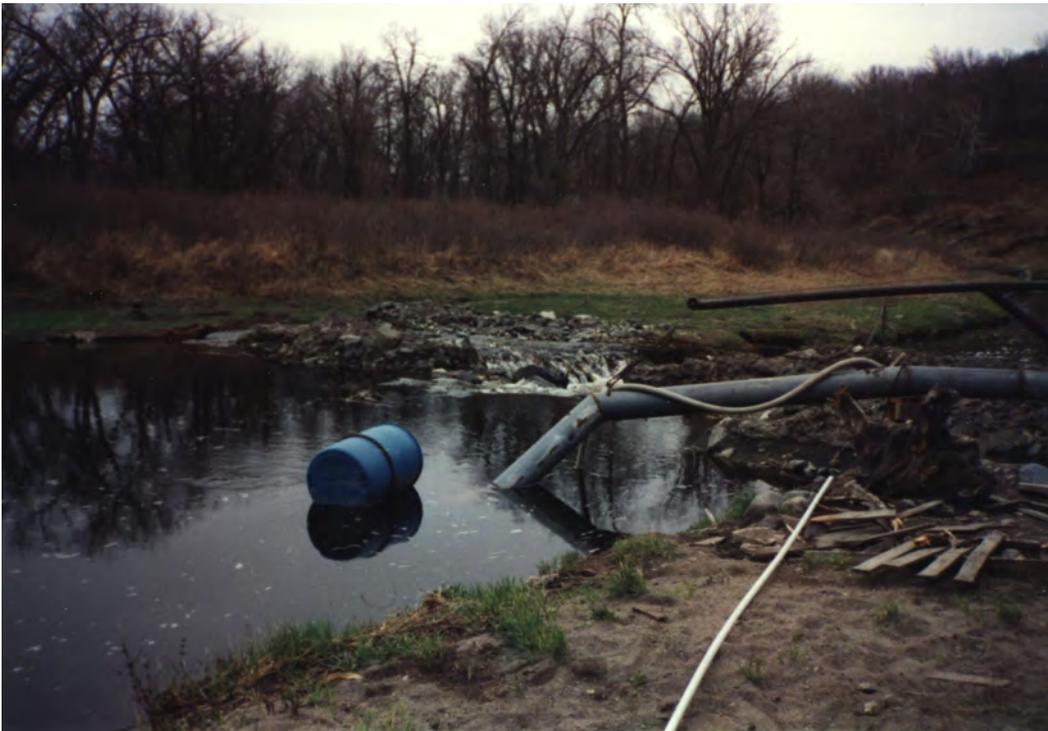
Coffer Dam and Intake for the First Point of Diversion (1993)

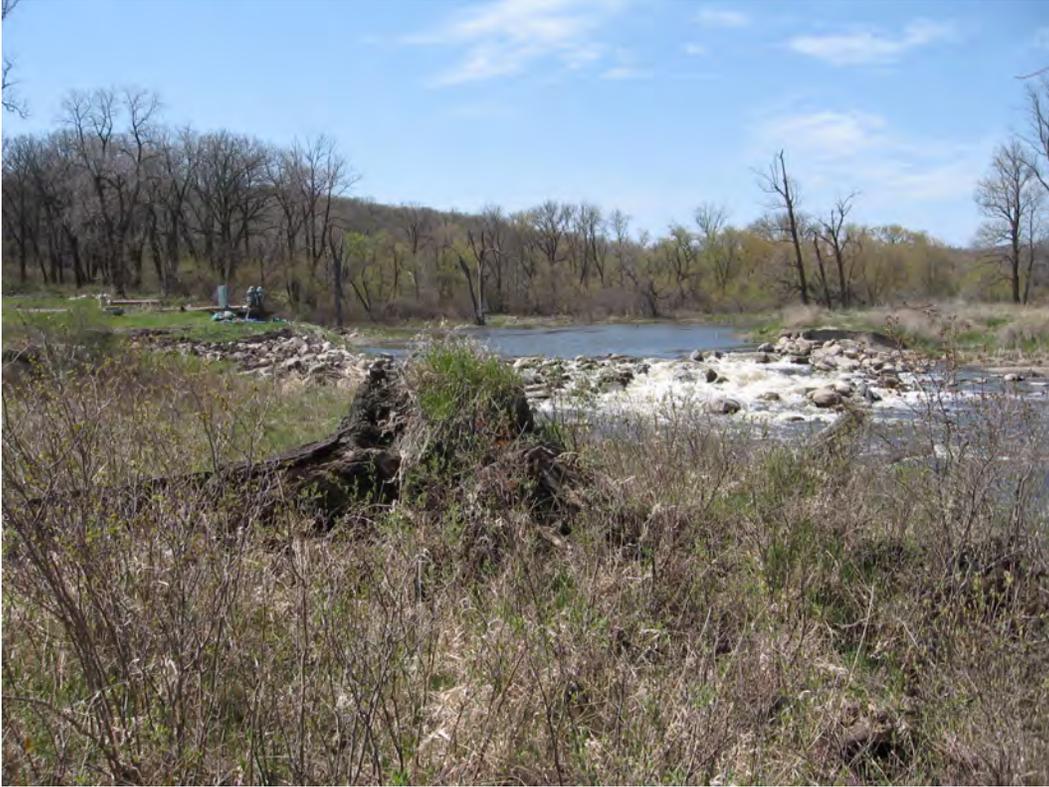
Coffer Dam and Intake for the Final Point of Diversion (2009)

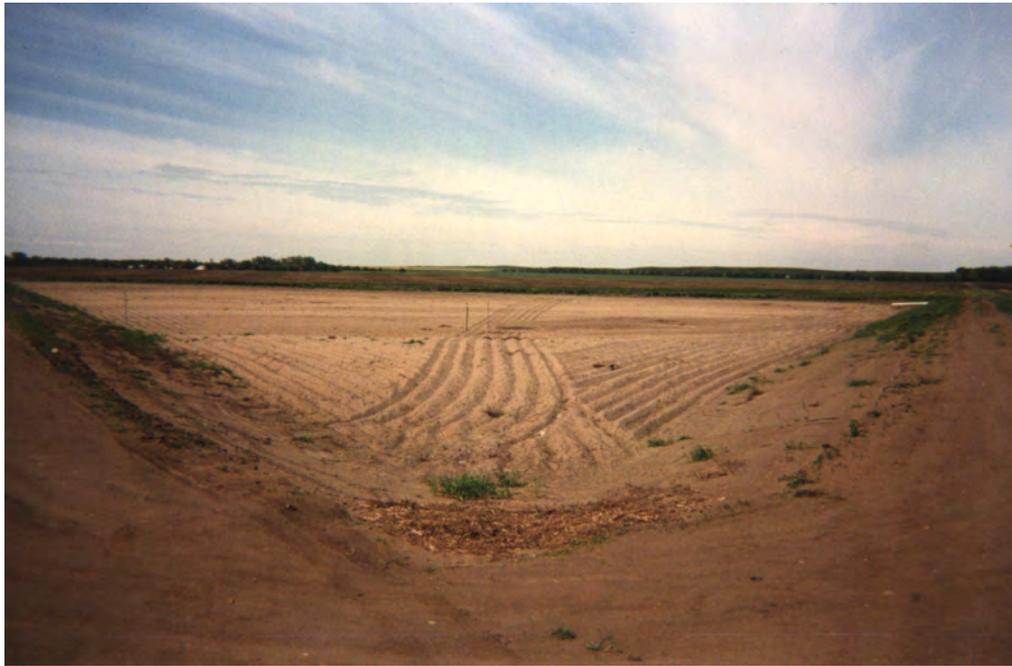
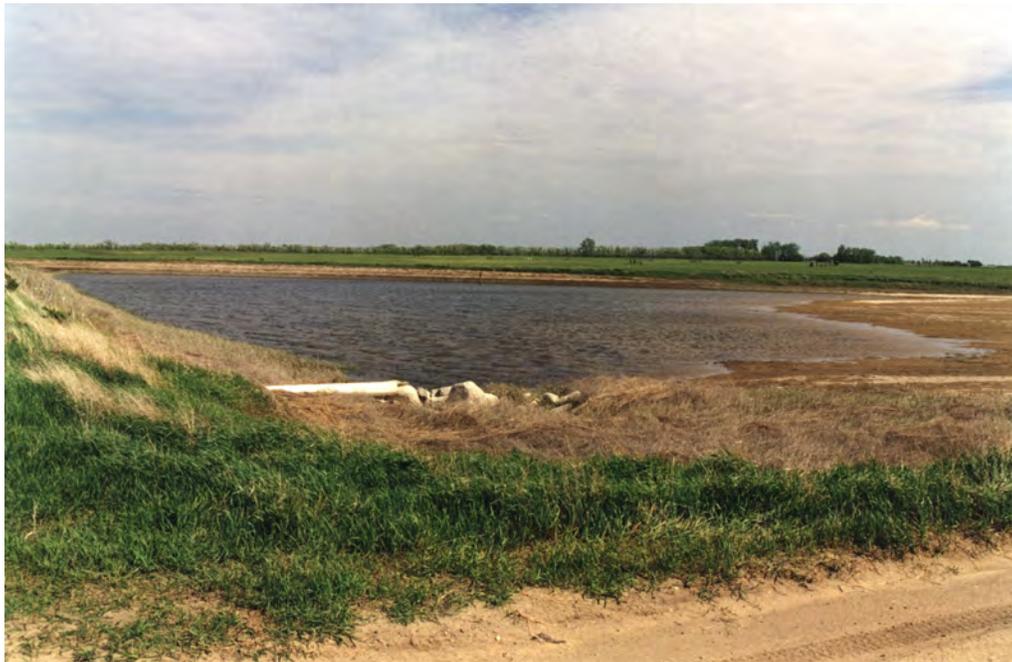
Figure 9. Pilot ARR basin: (A) prior to the pilot basin operation in the fall of 1992; and (B) during the water spreading phase of the spring 1993 pilot basin operation.

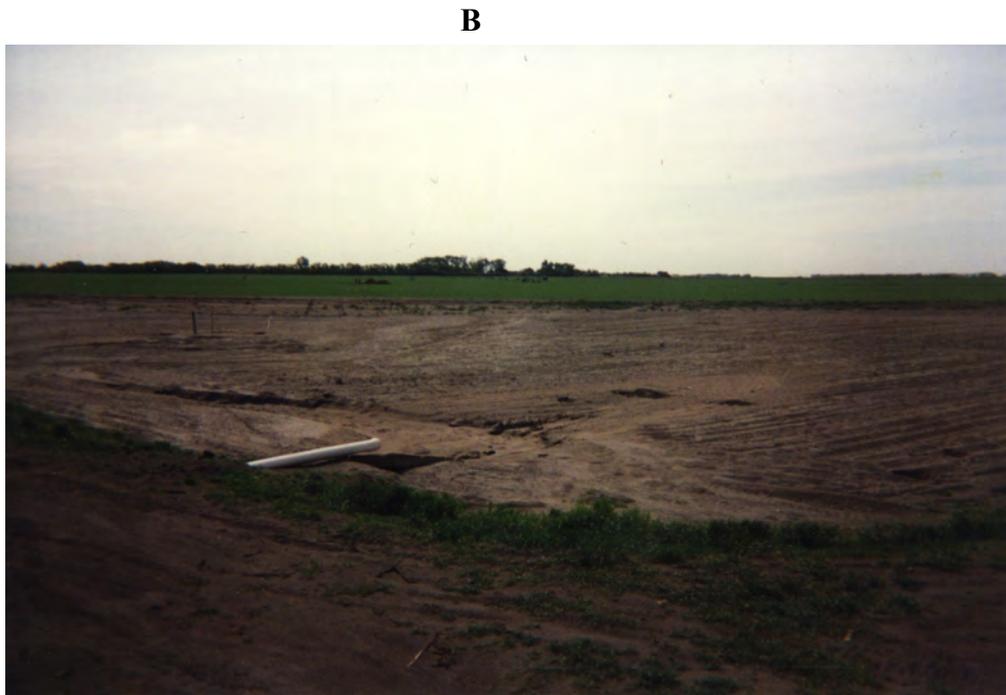
Figure 13. Schematic diagram (A) and photograph (B) of basin floor conditions after the spring 1993 pilot operation. Clogging characteristics for (A) are described in the text.

In basin section A1 (Figure 13A), located in the immediate flow path from the inlet pipe, there was a one-inch sandy crust overlying a darkened sandy soil that looked like topsoil to a depth of about 18 inches. Below the 18 inch level was clean sand. In section A2, there was a thin filter cake of about 0.07-inch thickness, with a range of about 0.03 inch to 0.12 inches. Underlying this was about 8 inches of medium sand, which overlay a dark fine sand to about 18 inches. The clean sand appears to have been deposited later in operation, after an initial period of infiltration. In section A3, the deep portion of the basin, there was a filter cake with an average thickness of about 0.29 inches, with thickness varying from 0.18 to 0.48 inches. Underlying the clay filter cake was a horizon of dark sandy soil to a depth of 12 inches. Beneath the top 12-inch layer were gravel and stones, intermixed with some clayey aggregates. Sections A4 and A5 had a thick crust rather than a filter cake. The cemented crust was about one-inch thick. Under the crust there was about seven inches of black soil in some cases, but usually there was no black soil at all. Below the seven-inch black soil, or in some cases immediately below the crust there was clean sand. There were large cracks to as deep as five inches in the cemented areas, and the internal portions of the cracks were lined with crust. Observation of the basin during operation indicated that the cracks were frequently present under water during operation. Their cause was uncertain.

Rates of infiltration are determined by the condition of the basin floor. After the Spring 1993 test operation the condition of the pilot-basin floor varied. These varying conditions are shown by area on Figure 13 as: (A1) nearest the inlet pipe there was a heavily scoured sandy area; (A2) in the primary flow path toward the deep center of the basin, there was a thin filter cake, but the floor was scoured and sandy; (A3) in the center of the basin, the deepest and first-flooded area, there was a thick and well-defined filter cake on the surface; (A4) in the eastern corner of the basin; and (A5) in the south corner of the basin the surface was smooth, and was characterized by a cemented surface rather than by a well-defined separate filter cake.

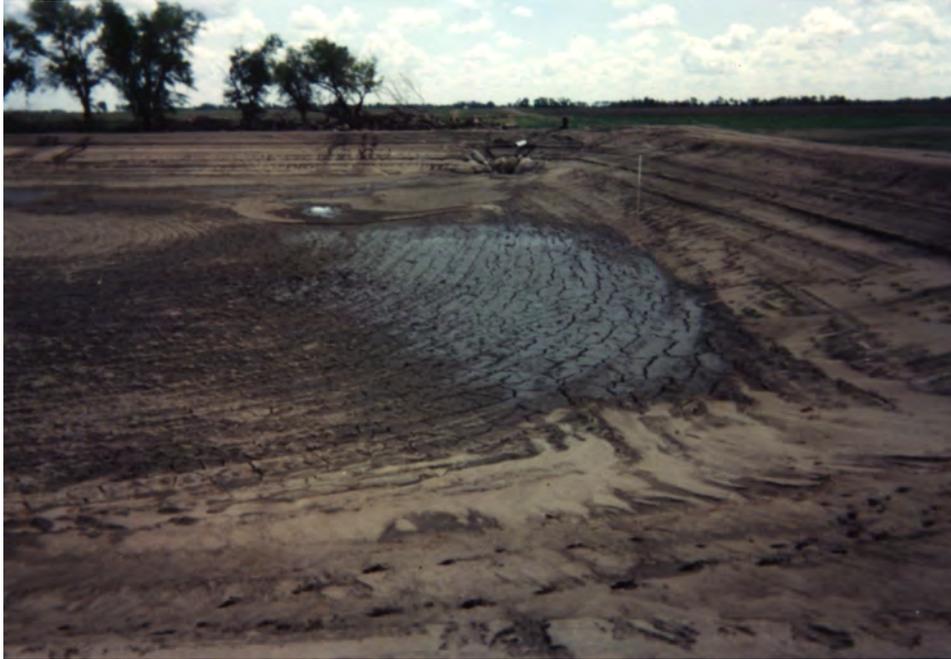
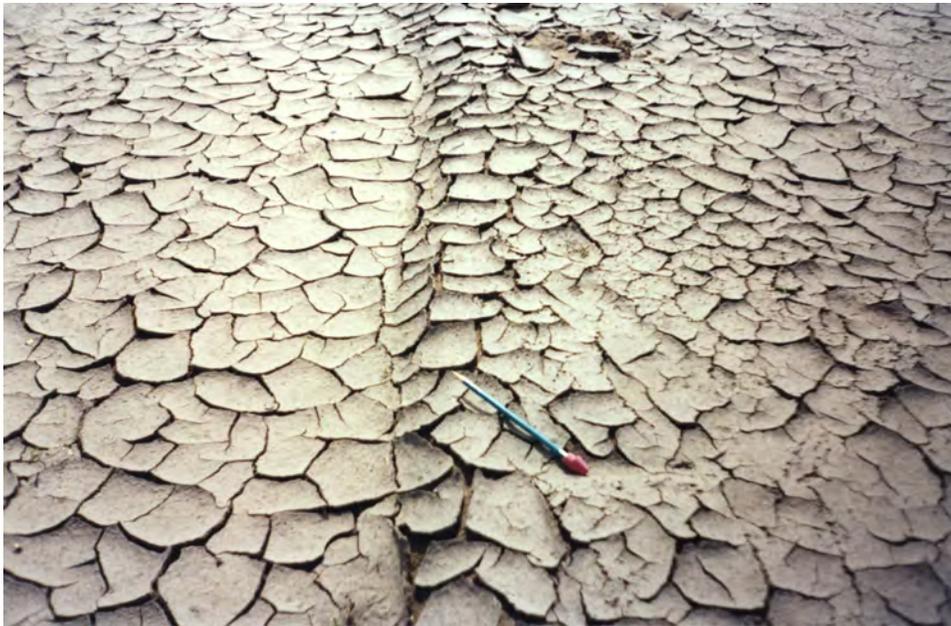
Figure 14. Surface sediment filter cake: (A) immediately after operation of the rectangular (2nd) basin, and (B) after desiccation of the basin floor.

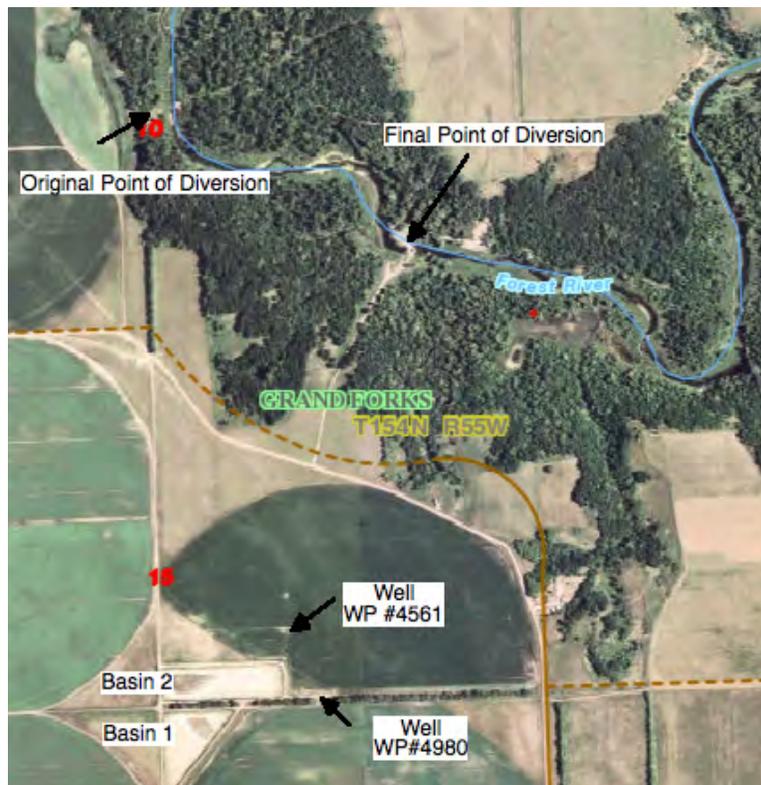
Figure 18. Location of ARR points of diversion on the Forest River.

Points of diversion from the Forest River are shown on Figure 18. From 1993 through 1998, water was pumped from the “original” point of diversion using a diesel pump at an average rate of about 1,850 gpm. Water was impounded using a low-head porous dam constructed of rocks, and a deep pool was excavated behind the dam for placement of a screened intake. In 1999 the “final” point of diversion was constructed, and both sites were pumped. The “final” point of diversion was pumped using two electric pumps (100 hp and 200 hp), having pumping capacities of 1,300 and 2,900 gpm. During 1999, 188 acre-feet were pumped from each site. After 1999 only the final point of diversion was used. In 2002 the maximum combined pumping capacity was upgraded to 3,700 gpm. The SWC required an inline flowmeter for measurement of recharge water. Discharge to the basin was monitored at least daily, and frequently more often. An annual report of recharge water and recovered waters was required.

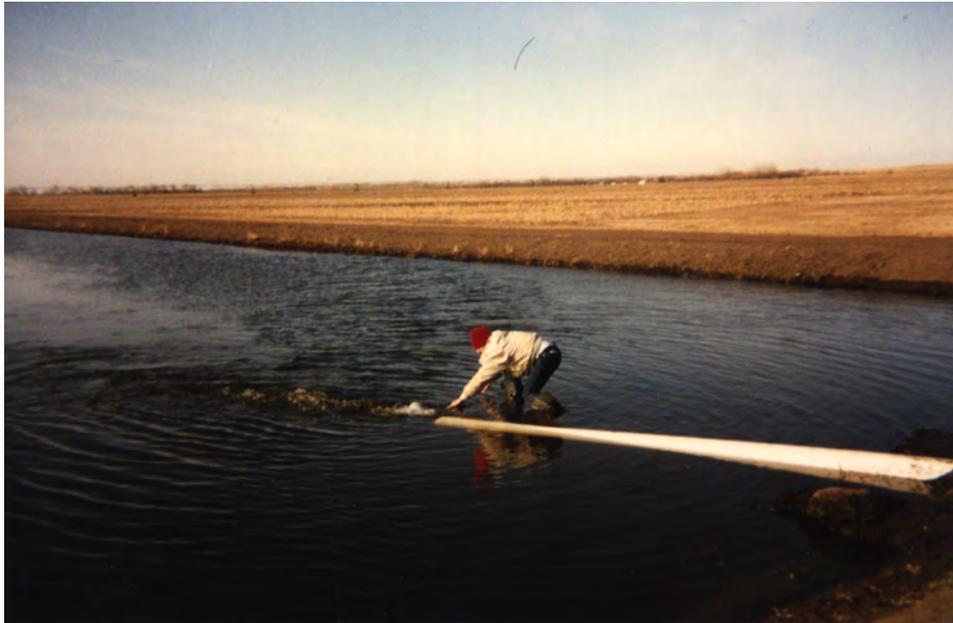
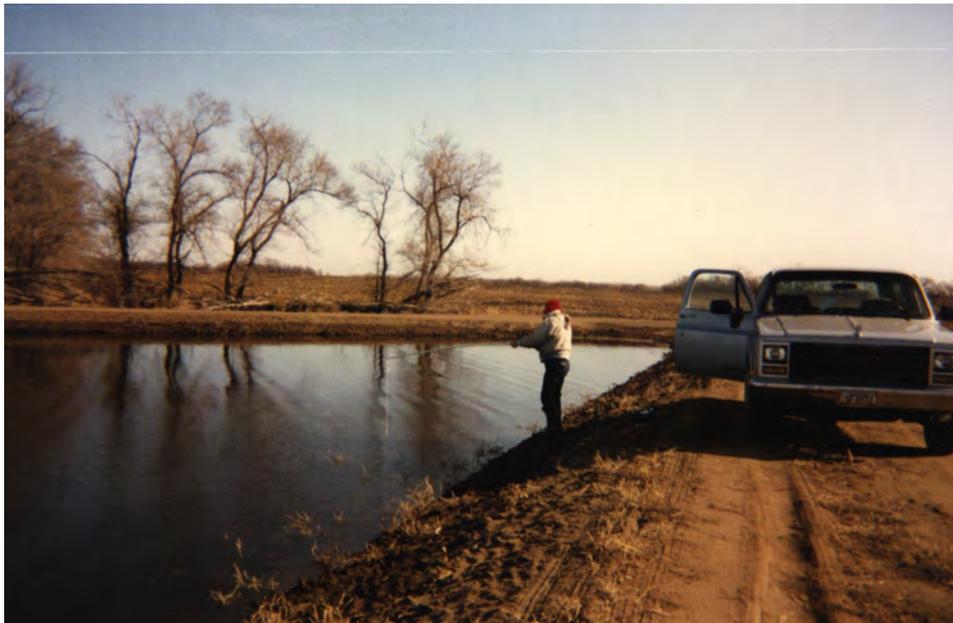
Figure 19. Collecting a water sample near the basin inlet (A) for water chemistry measurements; and (B) measuring dissolved oxygen in Basin 1, using an in situ DO meter.

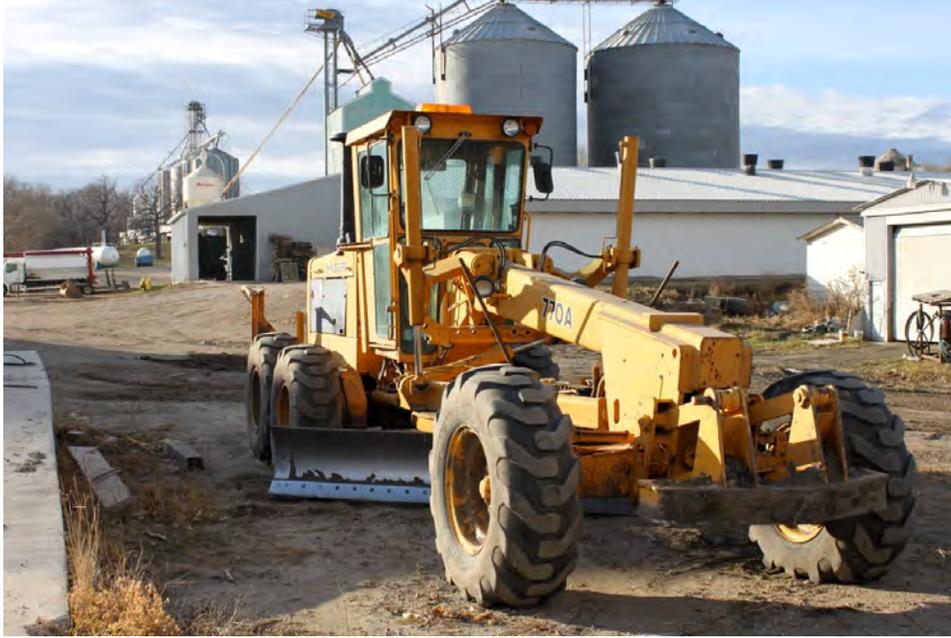
Figure B-1. John Deere 770TM grader used to “peel” filter cake. The grading operation begins on two edges of the basin, and the filter cake is scraped toward the center, where a single pile is collected for removal.

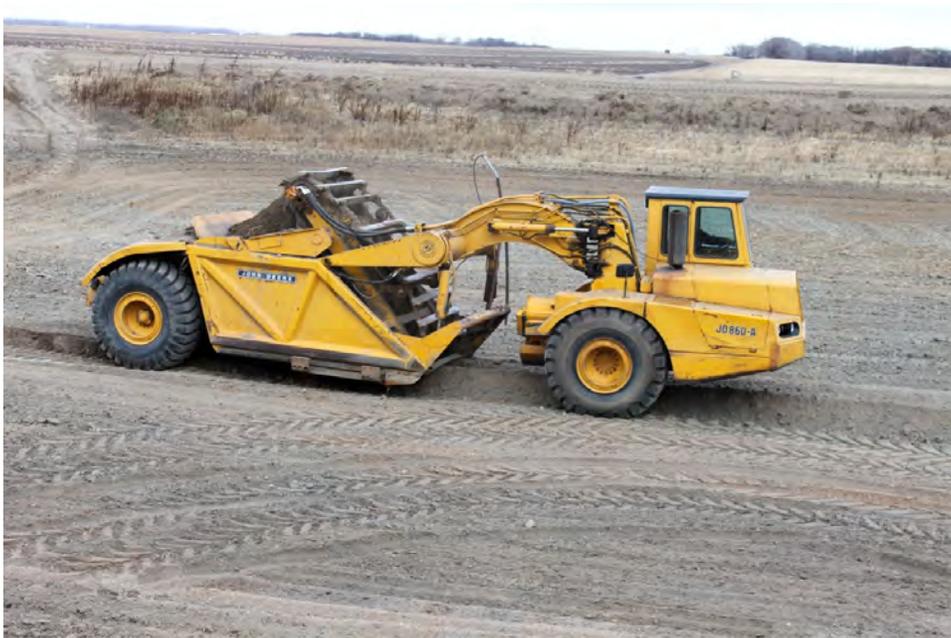
Figure B-2. John Deere JP686TM self-loading scraper, used to collect the filter-cake pile deposited by the grader.

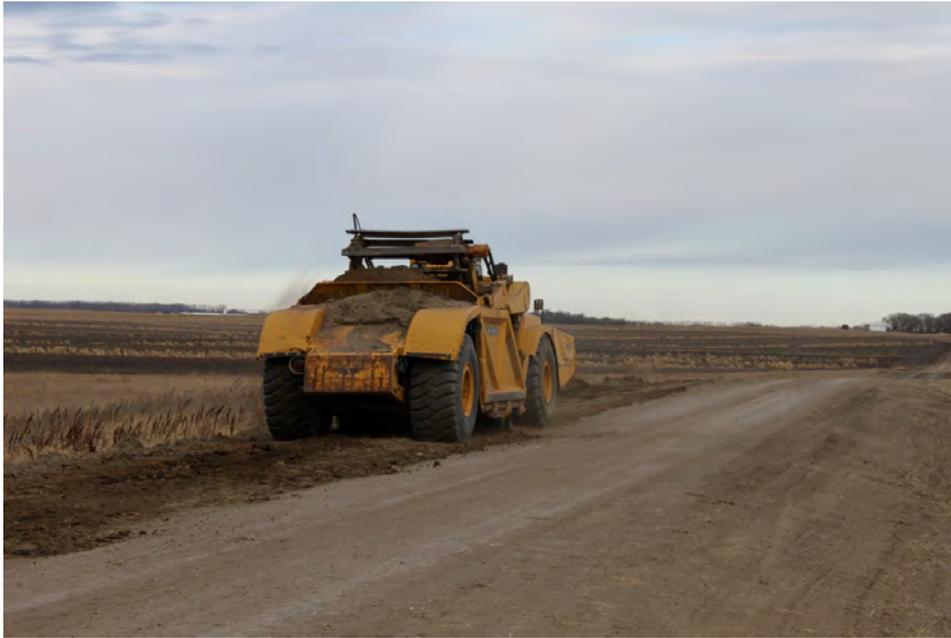
Figure B-3. John Deere JP686™ self-loading scraper depositing the filter-cake residue collected from the basin floor on the outside of the basin berm.

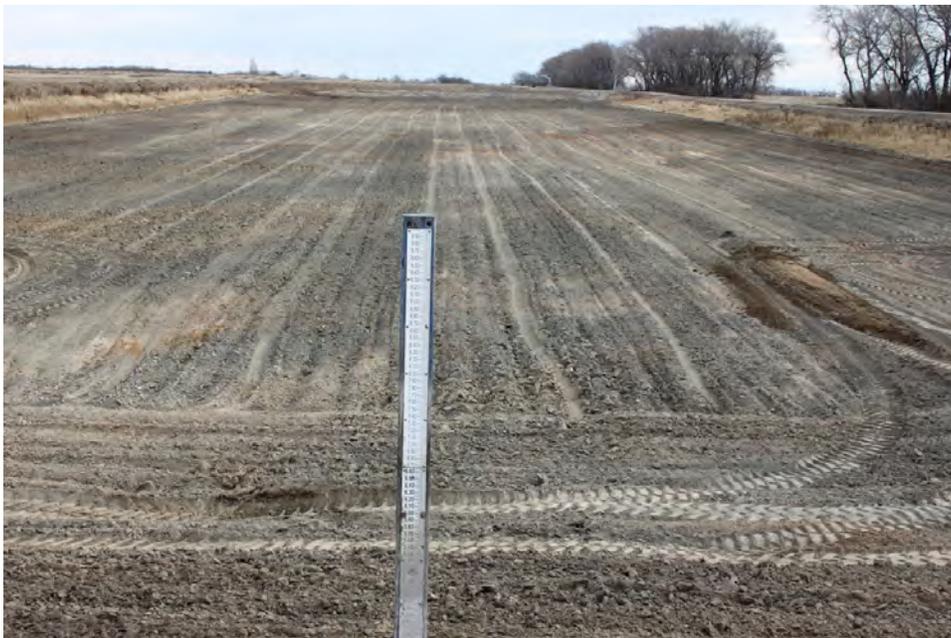
Figure B-4. Post-cleaning basin floor, 2009.
