Investigation Report – McGregor Dam

Williams County, North Dakota

SWC Project #528
July 2018

Investigation Report -McGregor Dam

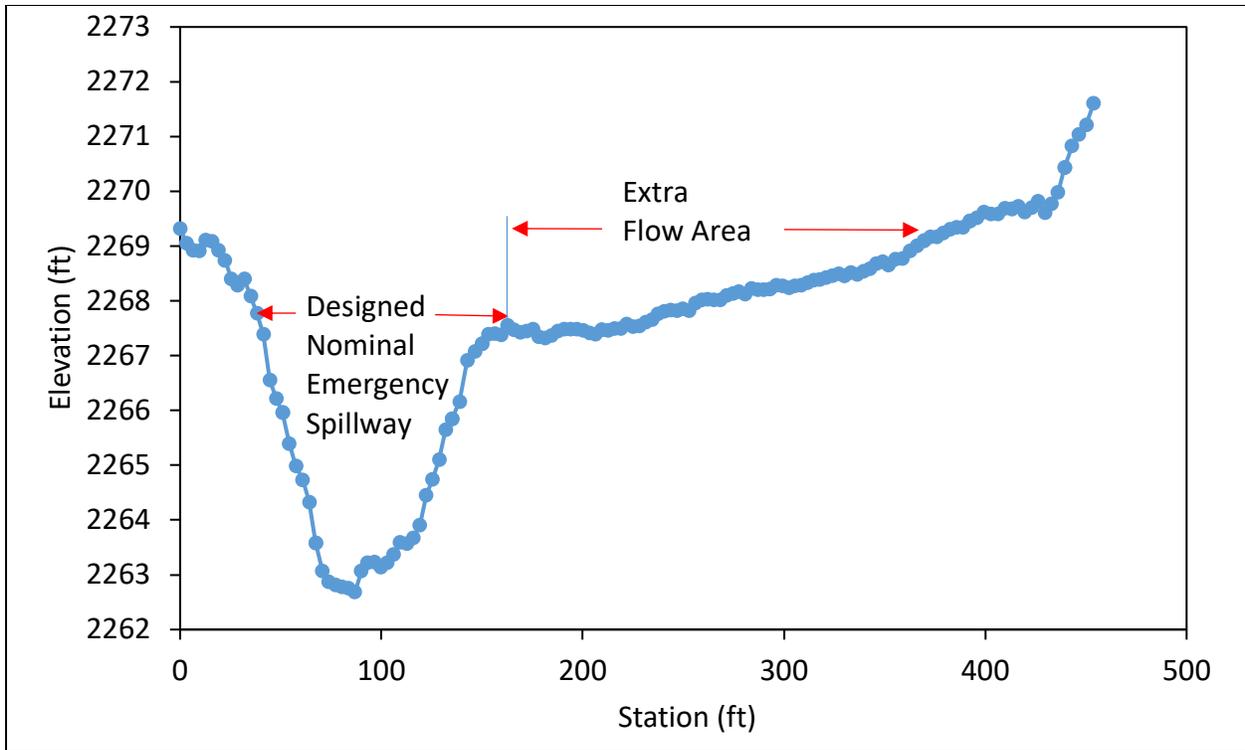
Figure 7. Profile of emergency spillway crest.

Three cross sections were used to estimate the emergency spillway rating curve in HEC-RAS 5.0 (Figure 6). Ground survey and LiDAR revealed the emergency spillway was not a simple trapezoidal shape (Figure 7). Rather an extra flow area existed to the southeast of the nominal

spillway. This area would convey water if the reservoir reached the overflow elevation of this area (Figure 7). HEC-RAS modeling was used to simulate water surface levels for 21 different discharges from 123 to 50,000 cfs through the emergency spillway. The most upstream cross section shown in Figure 6 represents the crest of the emergency spillway as illustrated in Figure 7. The simulation results from this cross section were used to develop the rating curve for the emergency spillway.

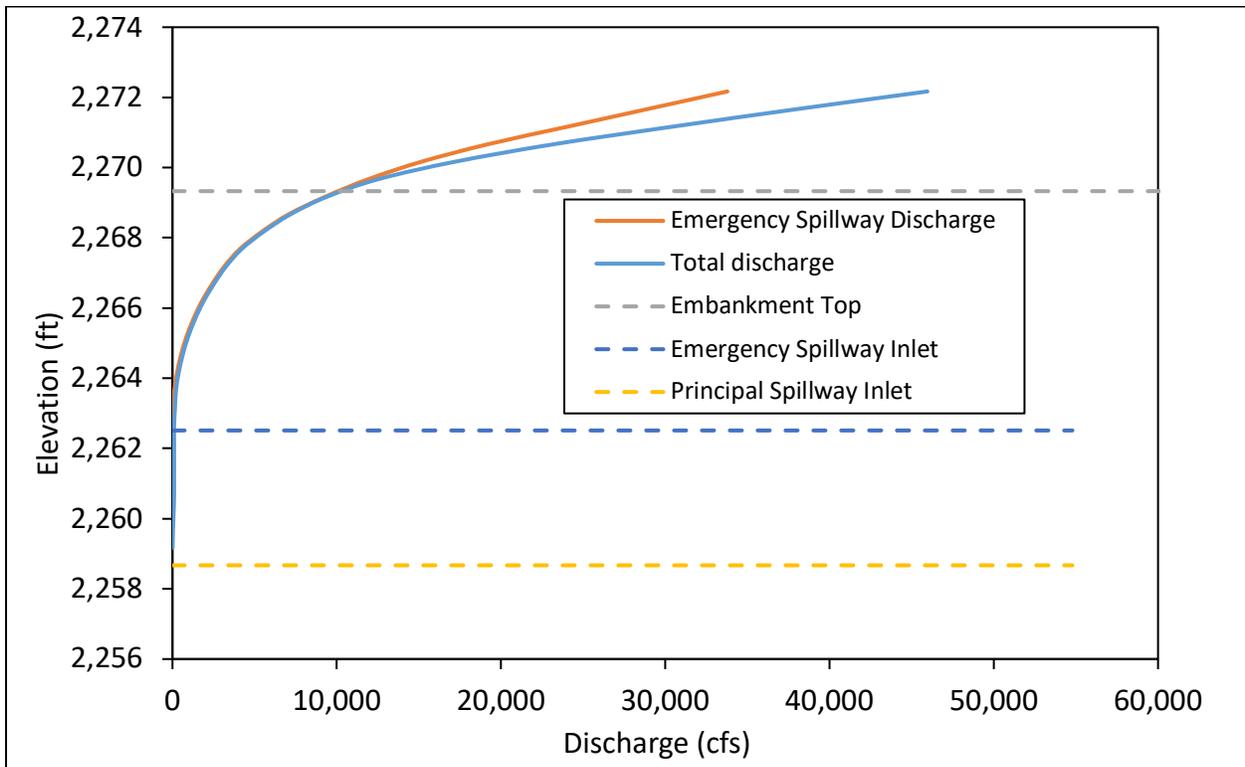
Figure 8. Total discharge (combination of principal spillway, emergency spillway, and overtopping) and emergency spillway rating curves for given pool elevations.

Embankment overtopping was assumed as broad-crested weir flow with a weir length of 900 ft. Emergency spillway discharge was 97% and 74% of total discharge at top of embankment and at elevation 2272.17 ft (2.8 ft higher than top of embankment), respectively (Figure 8). The emergency spillway is the dominant discharge route with and without over-topping once the water surface reaches the crest of the emergency spillway. The total discharge rating curve for the dam is displayed in Figure 8.

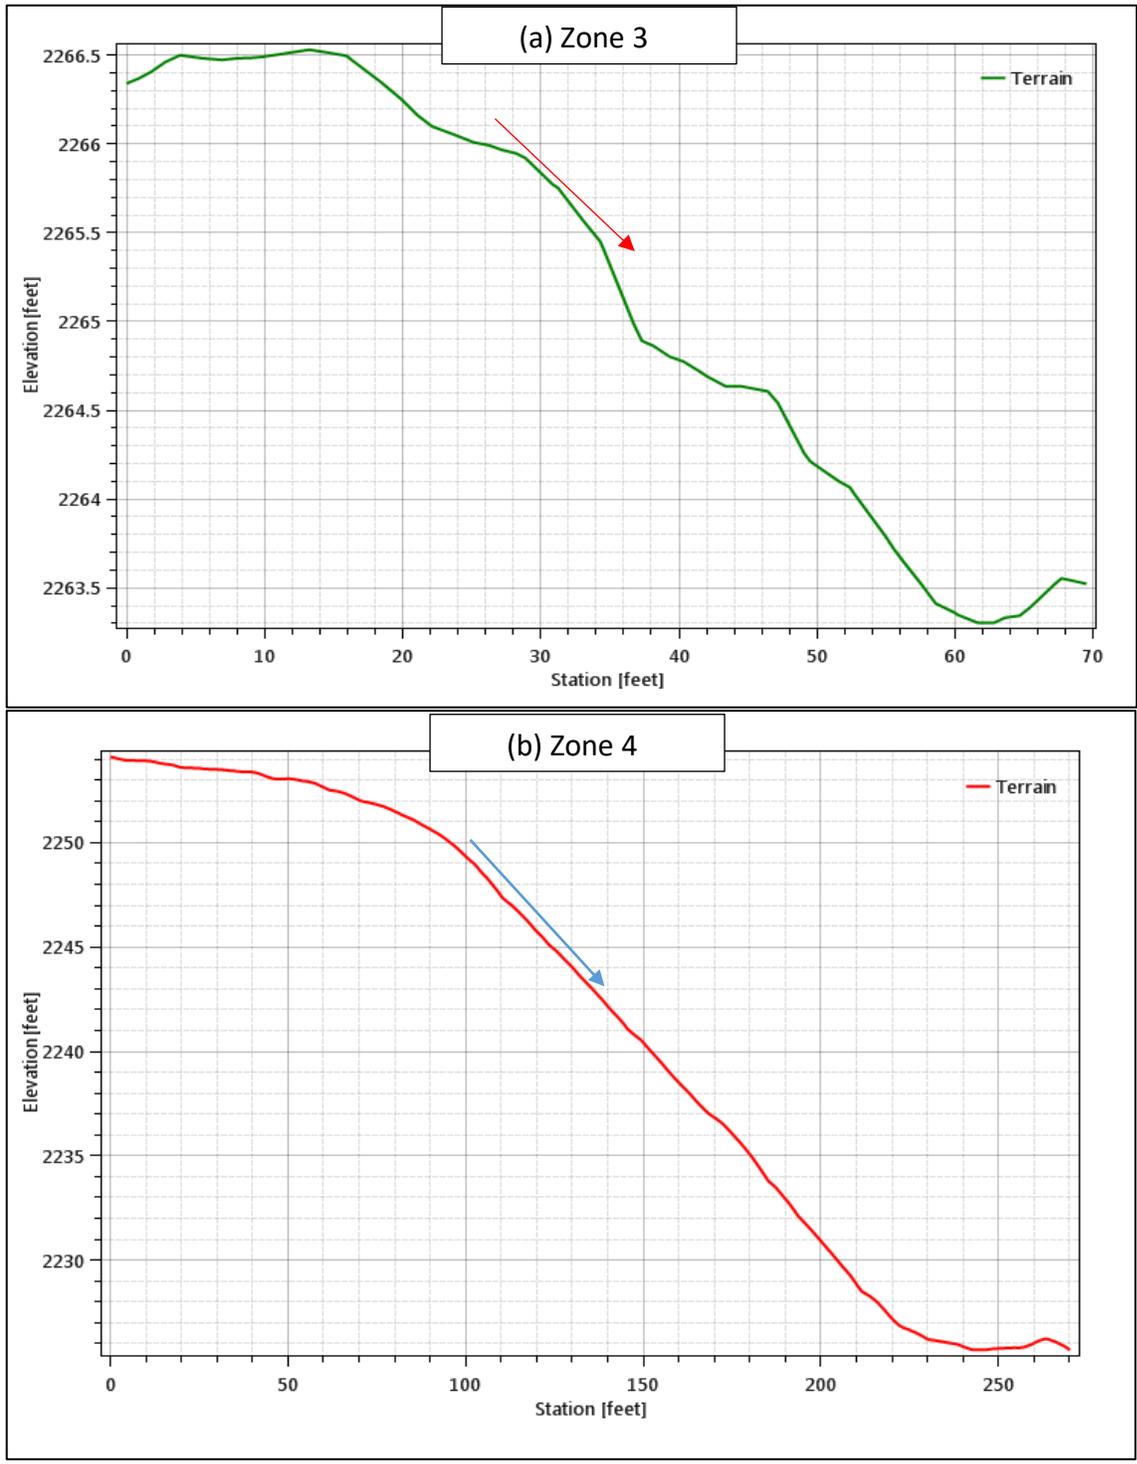
Figure 12. Ground elevation profile for (a) Zone 3 and (b) Zone 4.

The velocity analysis revealed additional erosion issues. In Zone 2 (Figure 10), the flow velocity increases up to 5.6 ft/s as water flows along the Highway 50 ditch. This situation increases the risk of erosion damage to the highway. In Zone 3 (Figure 10), eastward flow accelerated up to 5 ft/s through the down slope (Figure 12(a)). Water flowing through this zone would most likely cause erosion and increase the risk of higher magnitude flows being diverted along Highway 50. In Zones 4 (Figure 12(b)) and 5, the northwestward flow accelerated through down slopes up to 12 ft/s and 24 ft/s, respectively. Since Zone 4 is adjacent to the embankment toe, with Zone 5 in close proximity, the high velocity flow in these zones would most likely increase the risk of erosion and collapse of the middle of the embankment.
