PRELIMINARY ENGINEERING REPORT

PAINTED WOODS LAKE FLOOD CONTROL PROJECT

MC LEAN COUNTY, NORTH DAKOTA

SWC PROJECT NO. 160

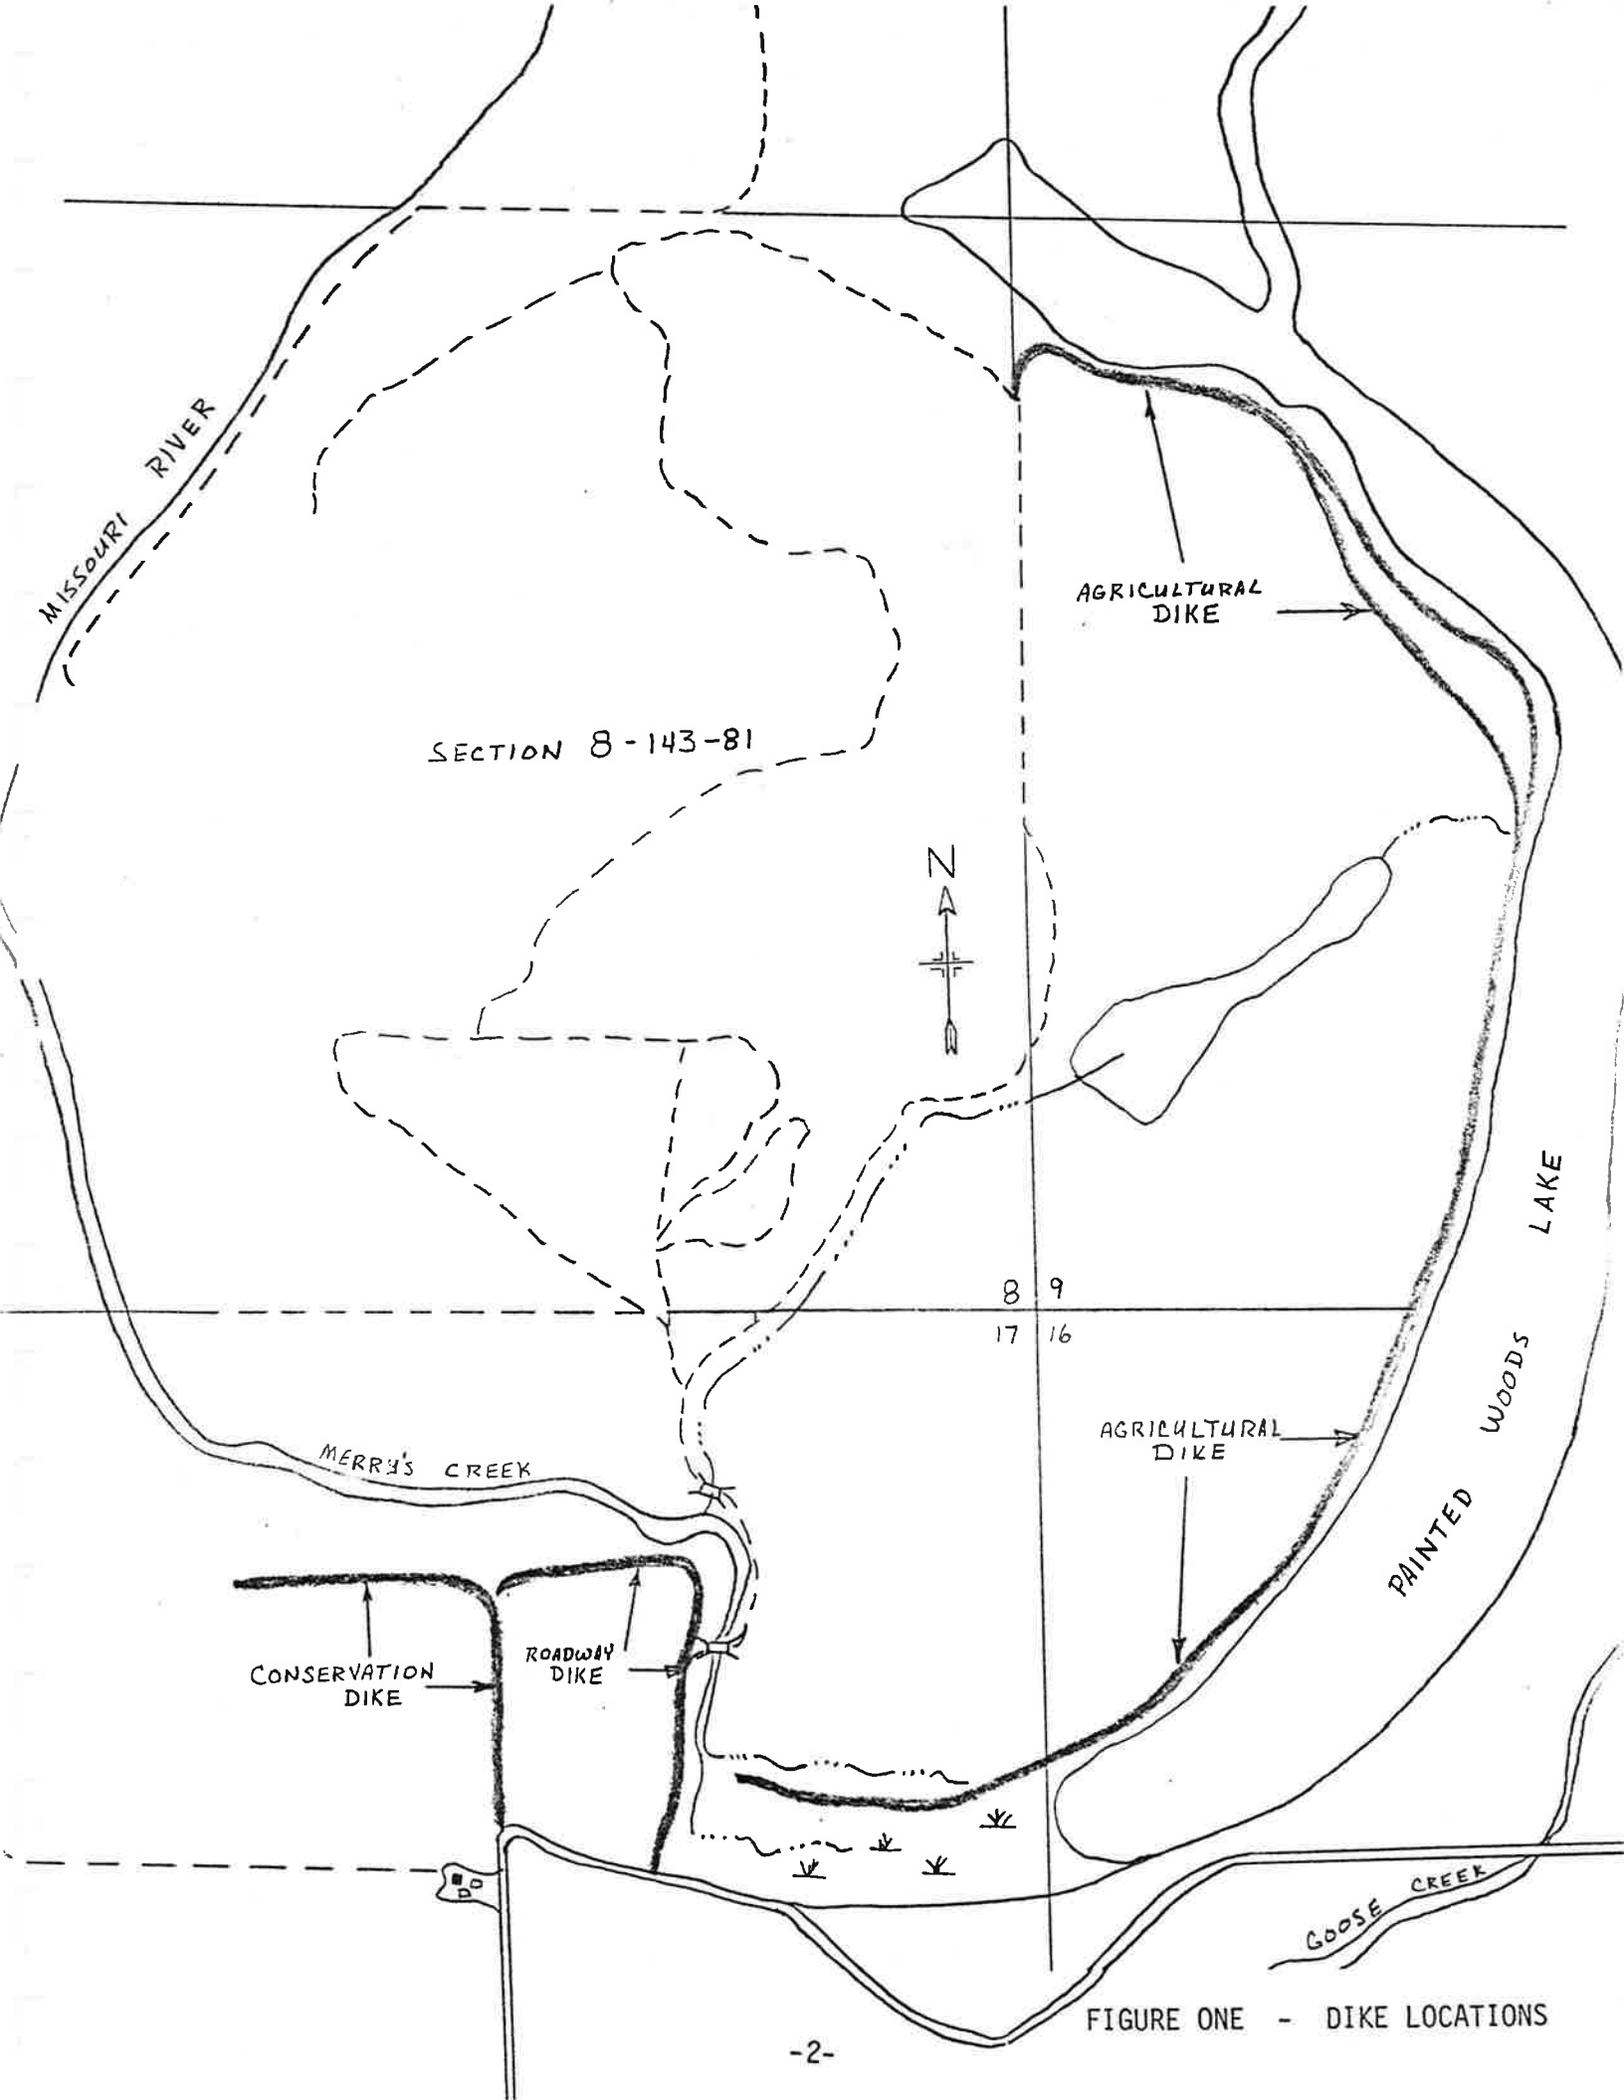
FIGURE ONE - DIKE LOCATIONS

To put certain items into perspective, the dikes along the west side of Painted Woods Lake were first permitted and constructed in 1957, to an elevation of 1660 m.s.l. as part of an irrigation project. Due to needed repairs, they were reconstructed in 1975 and limited by court stipulation to elevation 1660 m.s.l. The location of these dikes are as shown on Figure One. A roadway which acts as a dike was constructed near the area where the lake outlets into Merry's Creek and the land west of the roadway was leveled (SCS Project) for farming. Another dike has also been constructed west of this area. The roadway forces overflow from the lake into Merry's Creek at one location instead of allowing the water to spread out and enter the creek in a number of locations. However, because the roadway and dike west of the roadway were overtopped in 1979 and 1982, they appear to have had very little effect on those floods.

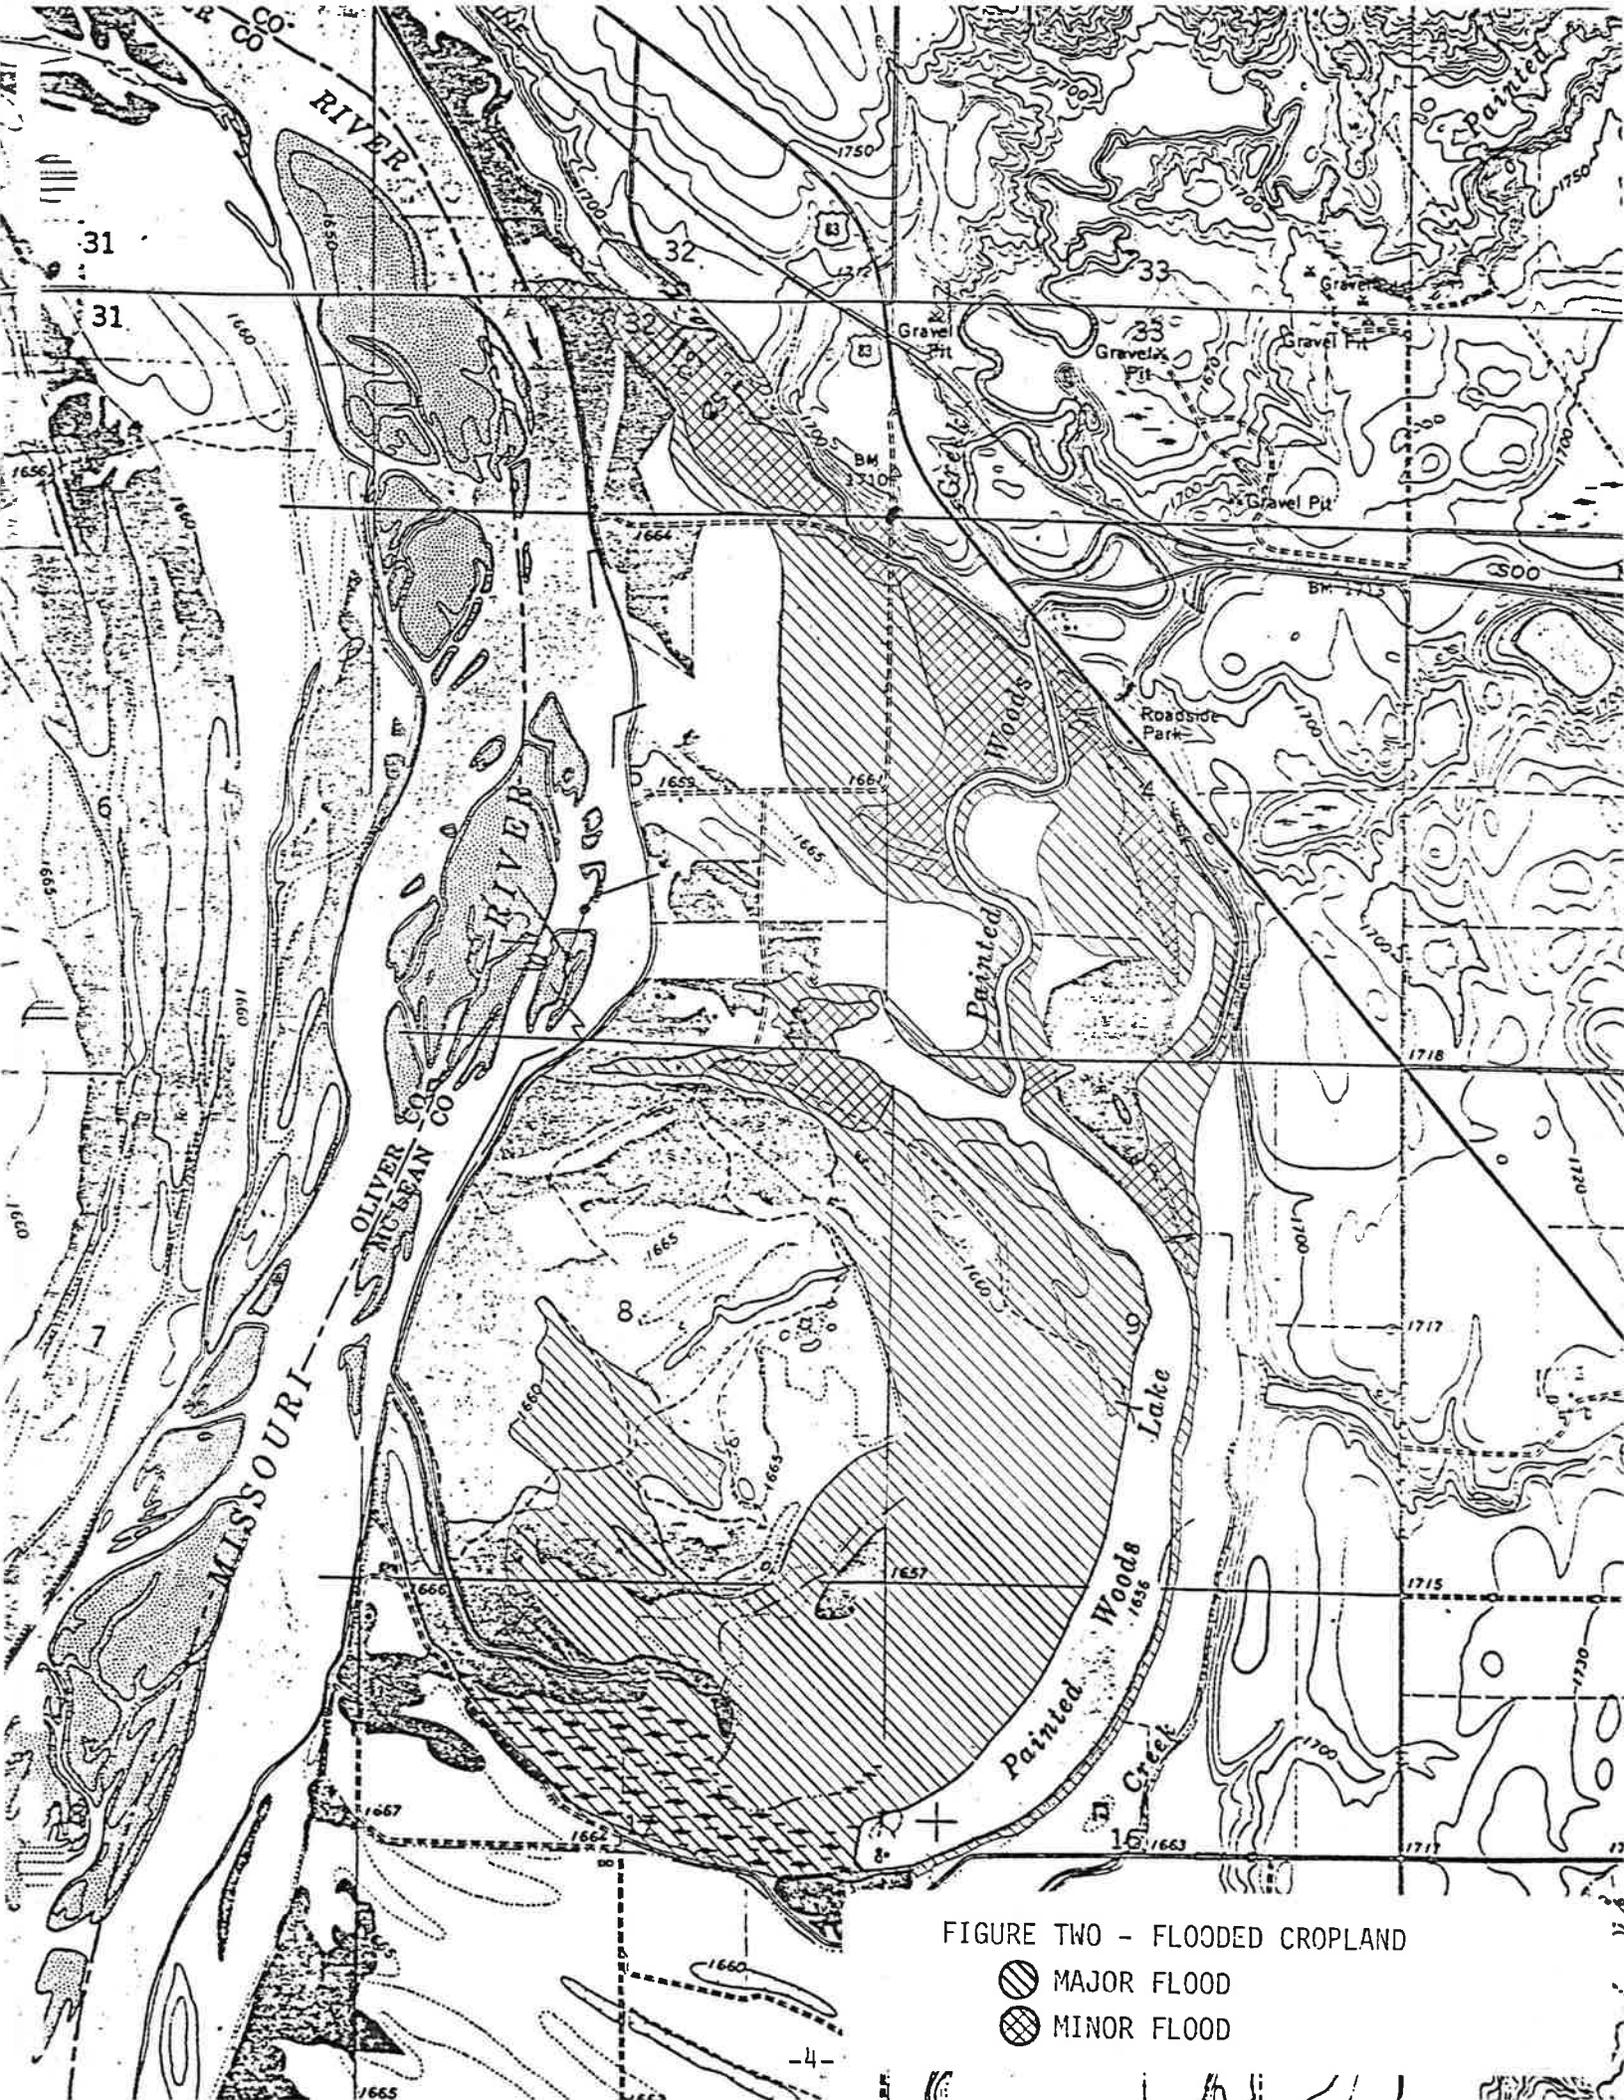
FIGURE TWO - FLOODED CROPLAND

MAJOR FLOOD
-

MINOR FLOOD

The conditions which have existed in the Painted Woods Lake area are the result of a wide range of events. The past decade has been one of above normal precipitation and delays in spring snowmelt temperatures have caused an increase in spring runoff and subsequent flooding. In addition, releases by the Bureau of Reclamation from the McClusky Canal have increased the flows to the lake. The resulting floods have caused damages to both cropland and developed real estate within the Painted Woods Lake area. The primary locations of flood damages are shown on Figures Two and Three.

those which occurred in 1979 and 1982. These dikes do, however, have an effect during smaller hydrologic events. The areas to the northwest and west of the lake, as shown on Figure Two (Minor Floods), are lower in elevation than the top of the dikes. This combined with the limited storage and outlet capacity cause backwaters to flood these areas on small hydrological events. Once the dikes are overtopped, however, they have very little effect on flooding in these areas. The limited capacity and flat gradient of Painted Woods Creek just upstream of the lake is also a cause of flooding.

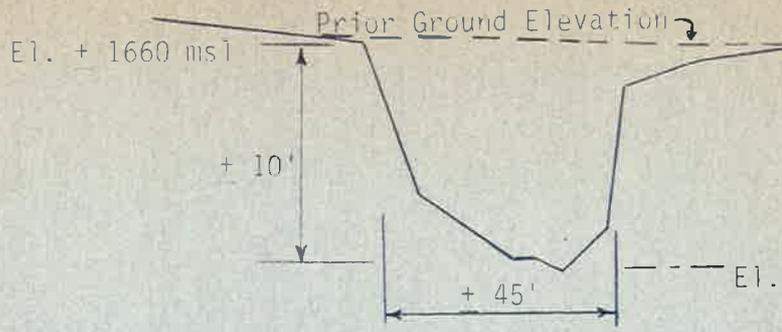
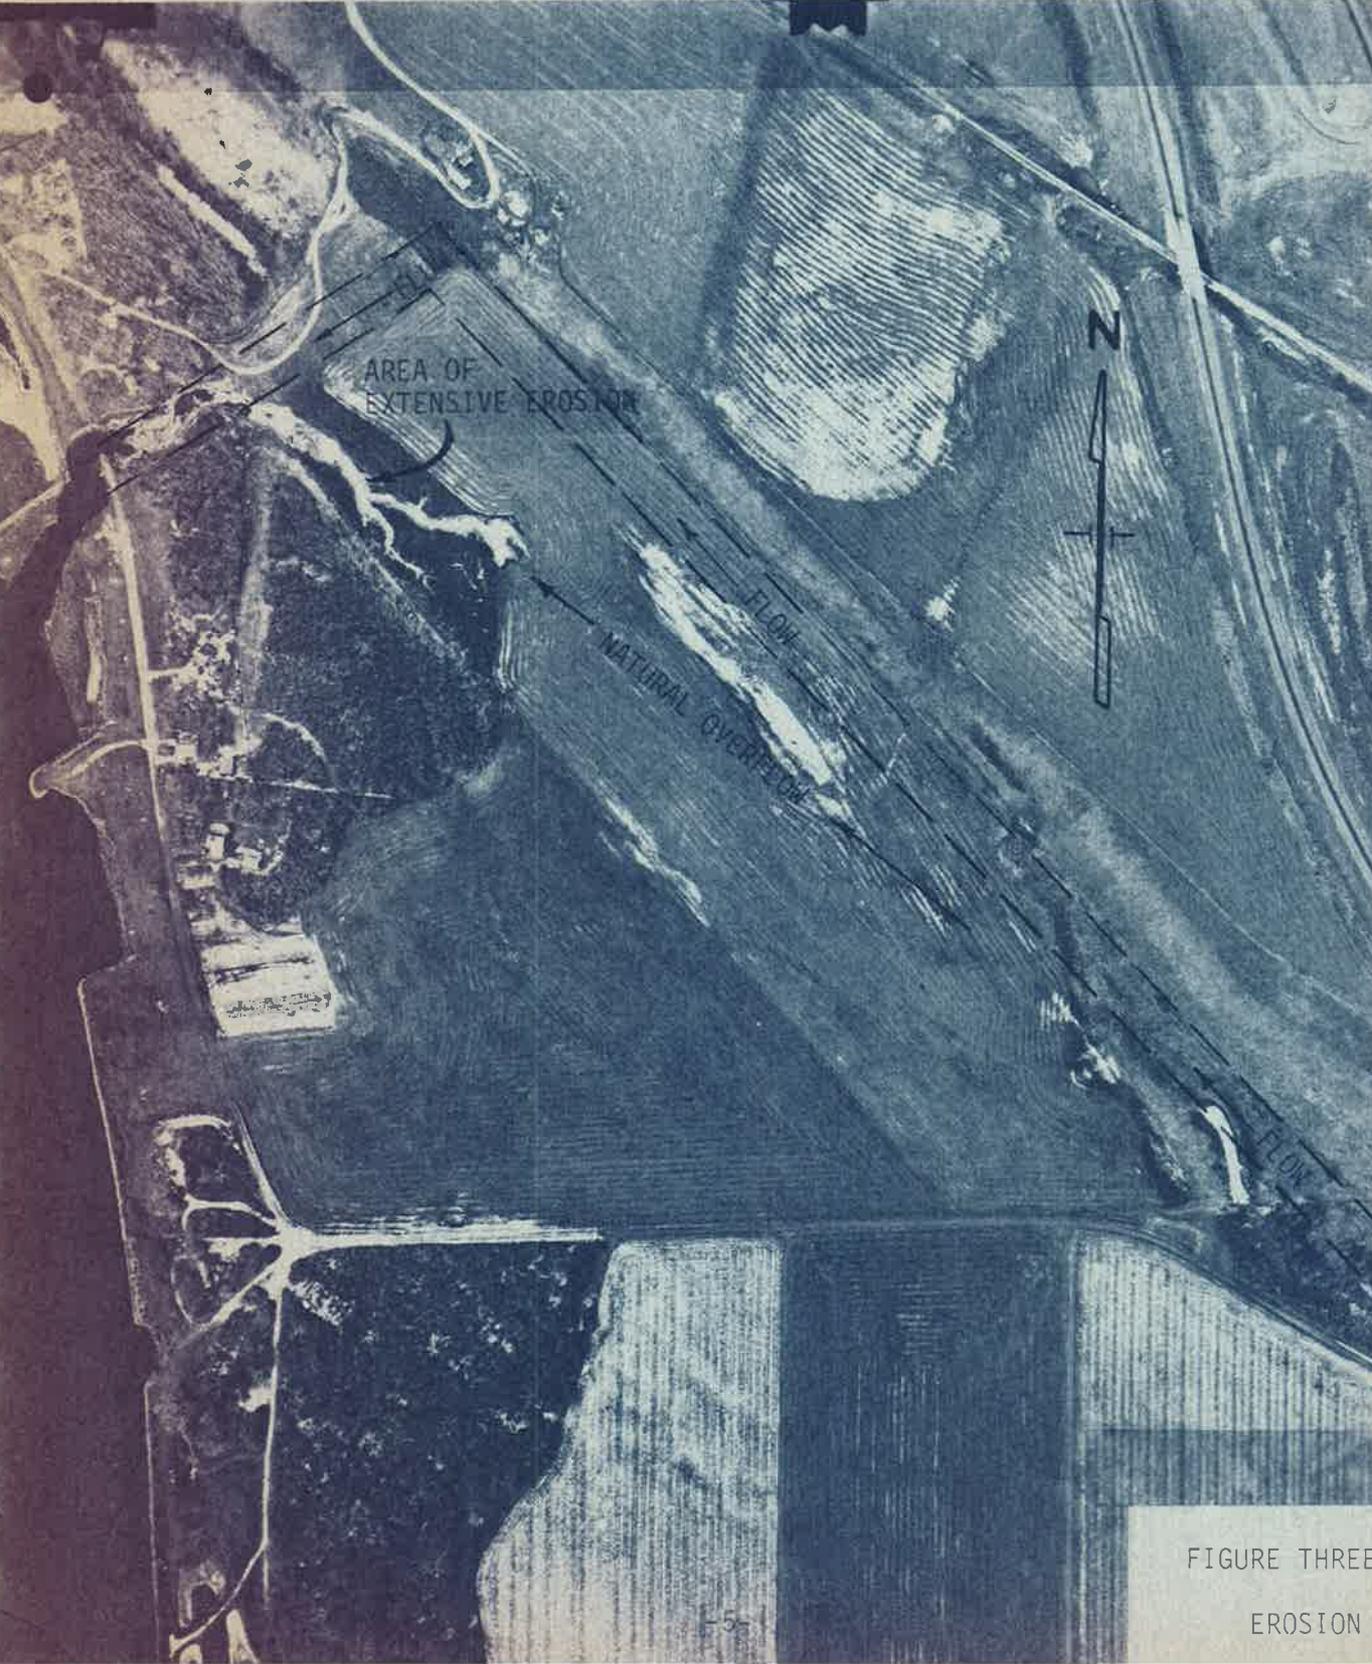
FIGURE THREE

EROSION DAMAGE

TYPICAL SECTION

EROSION

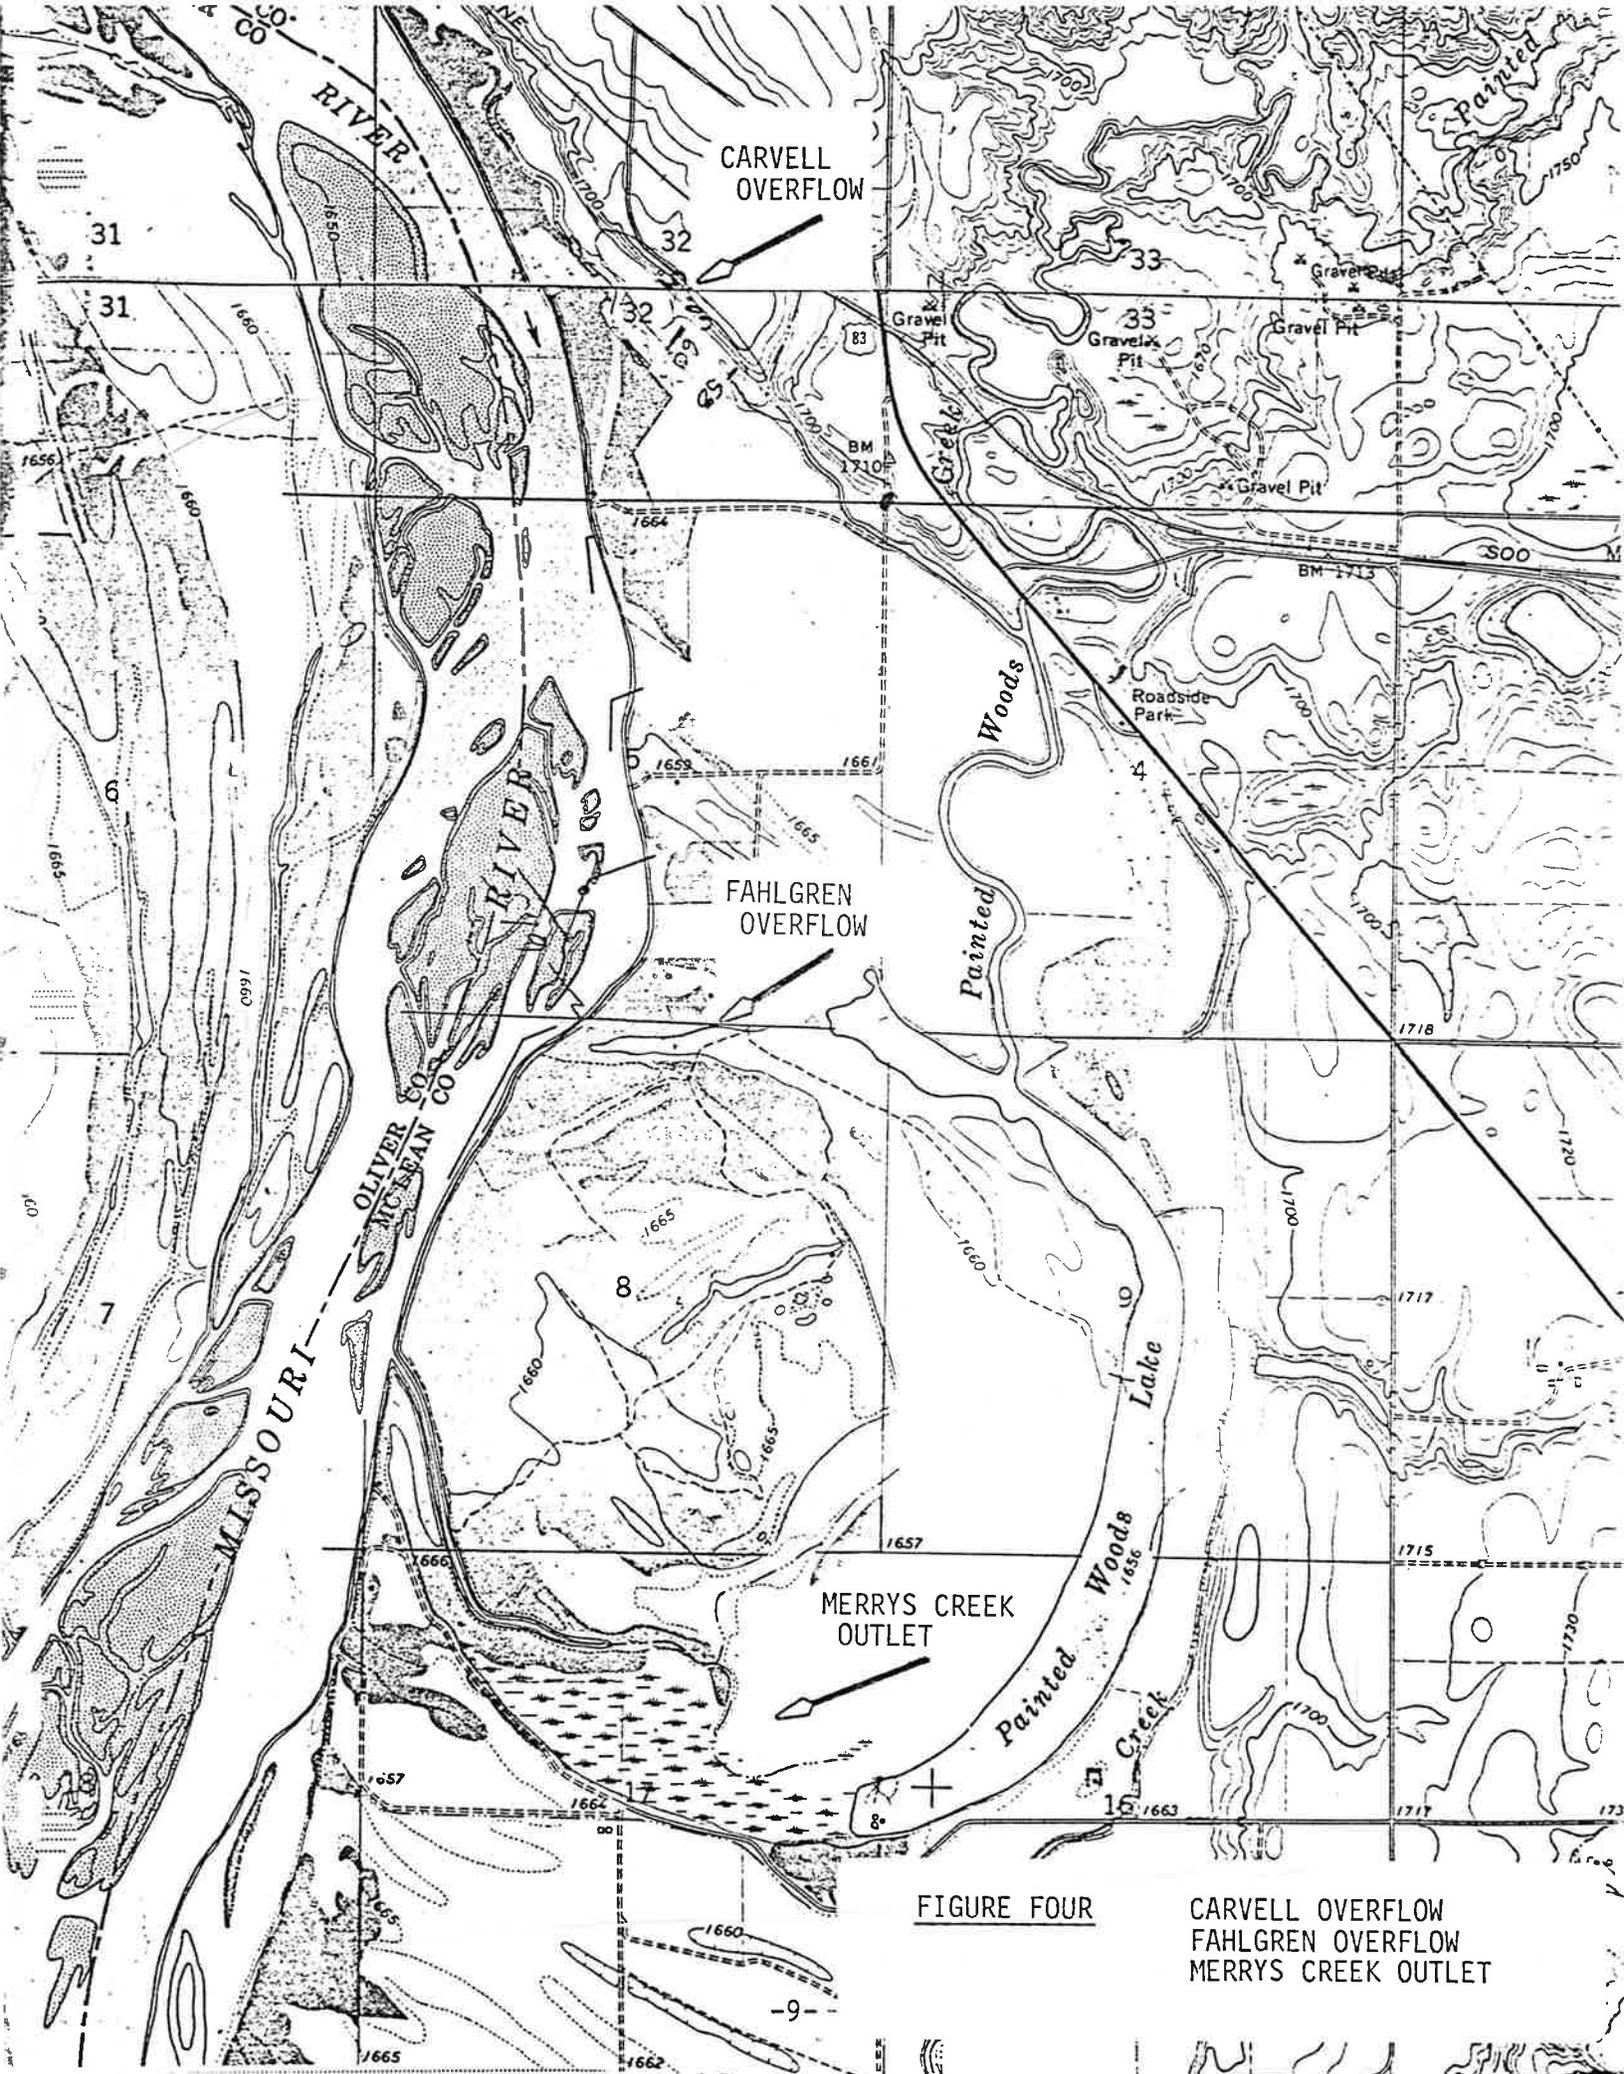
FIGURE FOUR

CARVELL OVERFLOW
 FAHLGREN OVERFLOW
 MERRYS CREEK OUTLET

The northwestern highwater outlet (Carvell overflow) follows the old Turtle Creek riverbed to the northwest into Section 32, Township 143 North, Range 82 West, where it outlets into the Missouri River (Figure Four). The distance from Painted Woods Creek to the Missouri is in excess of 5900 feet. This greater distance and the requirement for structures makes improvements to this outlet very costly and therefore undesirable as a single flood control outlet. During the past few years, high lake elevations have caused water to flow through this outlet resulting in extensive erosion which has caused substantial damages to both cropland and real estate. Because of the extensive erosion, the existing overflow elevation has been lowered 1.6 feet to elevation 1659.8 m.s.l. (Figure Three). Presently, flood waters outlet through this area prior to the overtopping the dikes at Painted Woods Lake.

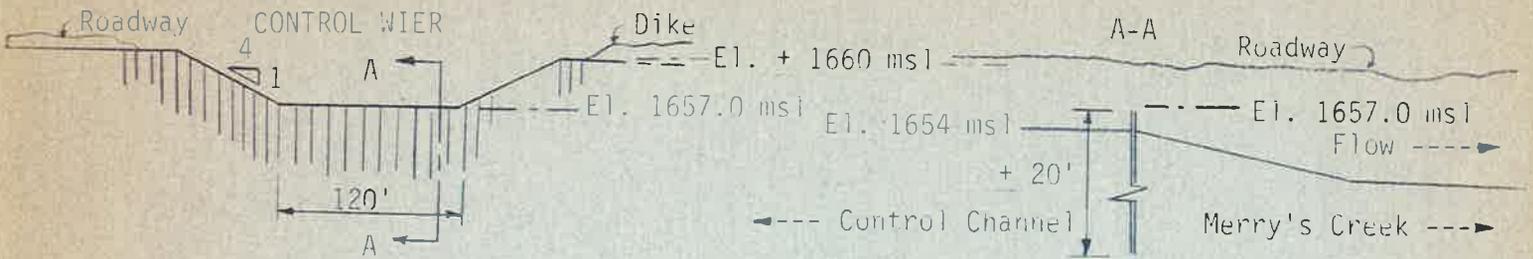
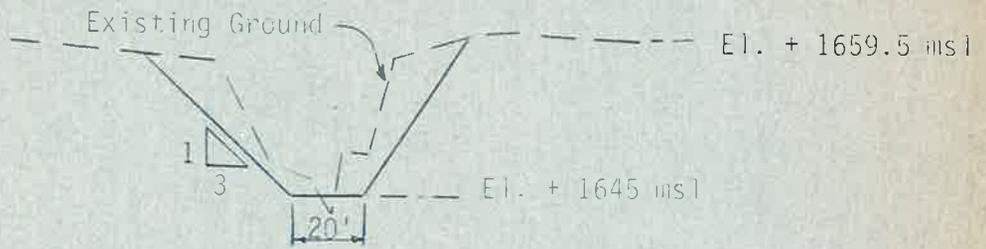
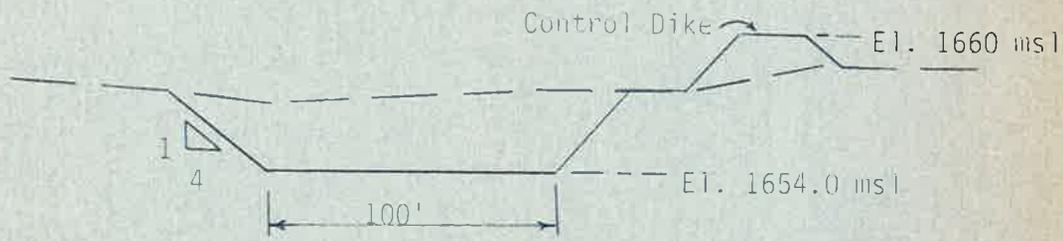
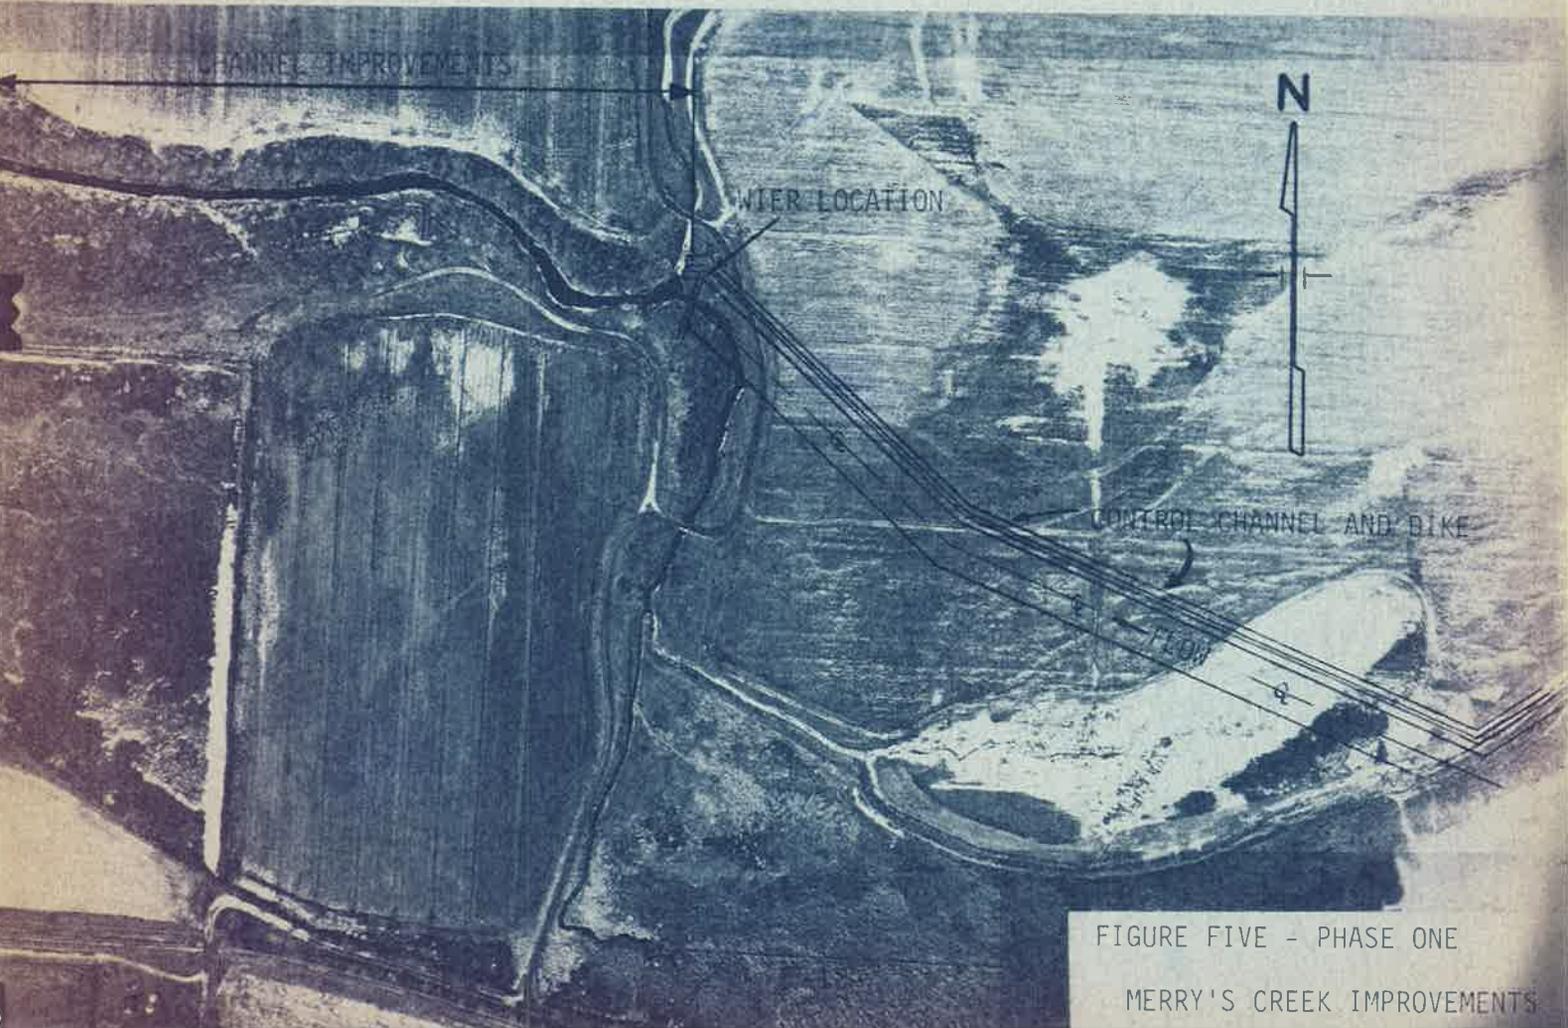
FIGURE FIVE - PHASE ONE

PHASE ONE IMPROVEMENTS

MERRY'S CREEK IMPROVEMENTS

CONTROL CHANNEL FROM LAKE

Under present conditions, erosion from Merry's Creek back into the lake will eventually result in the complete draining and loss of Painted Woods Lake. The Bureau of Reclamation's releases appear to have increased the erosion problem. The primary reason for the weir, is to regulate the flows into Merry's Creek at a given lake elevation and prevent the complete loss of the lake.

The present condition of Merry's Creek is very poor. The side slopes are very steep and highly susceptible to erosion, which has become very serious in

some areas. The velocities in the channel are in excess of 3 feet per second causing an increased probability of continued erosion on the open soils. The capacity of the bridge which crosses the creek was also of some concern; however, the placement of the weir downstream from the bridge, and the proposed control channel, provide the most effective location for these improvements. Other locations were considered but were found to be less adequate for controlling releases from the lake.

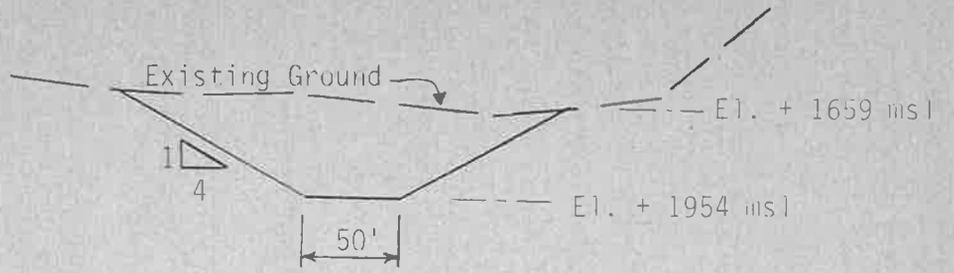
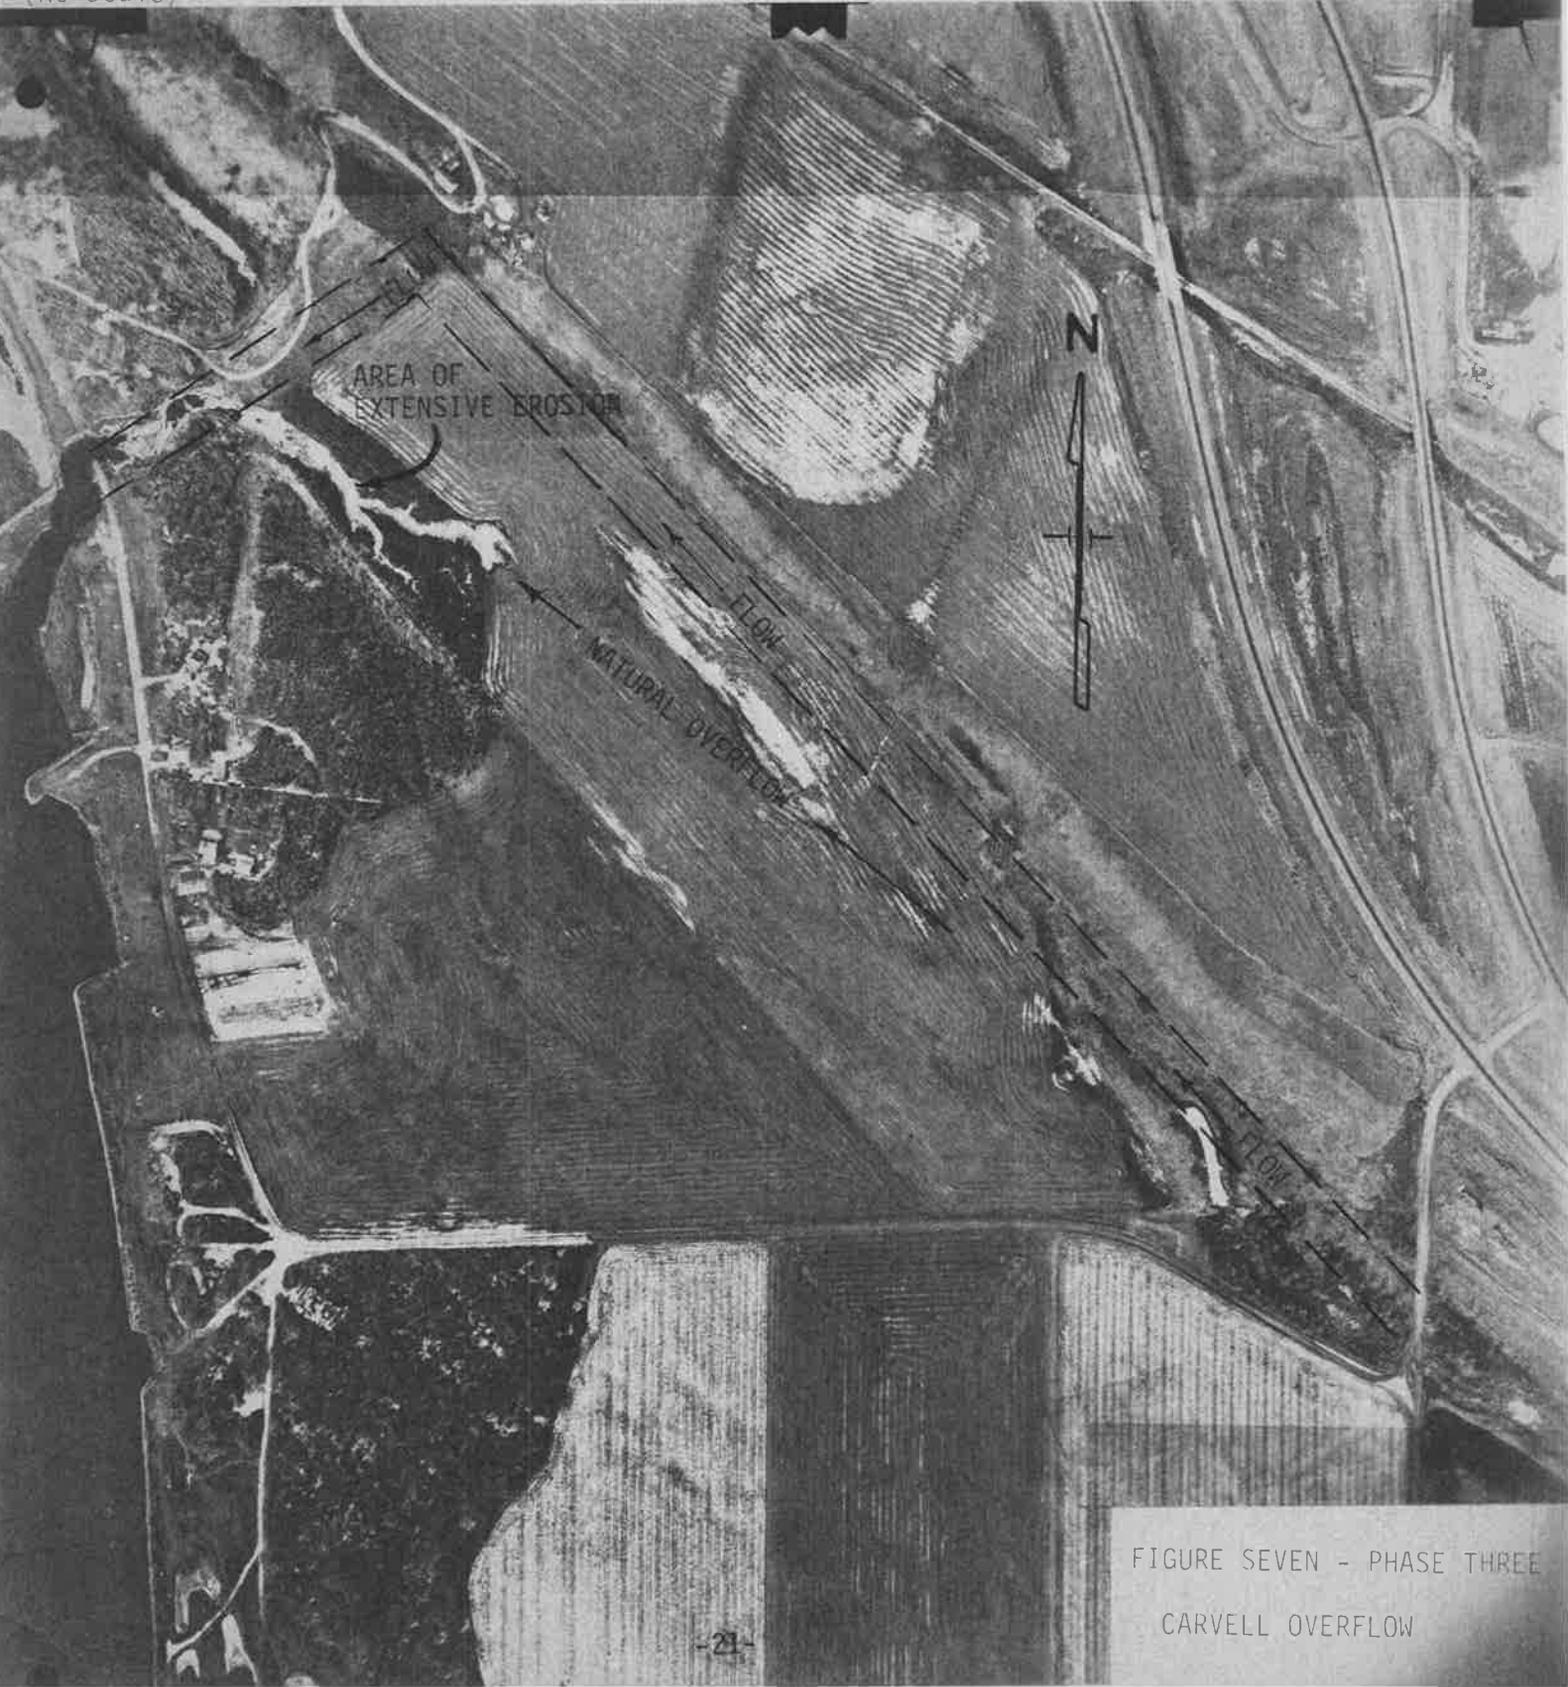
FIGURE SEVEN - PHASE THREE

PHASE THREE IMPROVEMENTS

TYPICAL SECTION

CARVELL OVERFLOW

The primary deterrent to the development of the northwest or Carvell outlet, as the single or only highwater overflow from this area is its high costs. There would be a need for several bridges, a large capacity channel, and other improvements which further increase its cost. Some improvements are required to prevent further damages in this area, even if Phase Three is not constructed.
